Renewing the Anderson connector

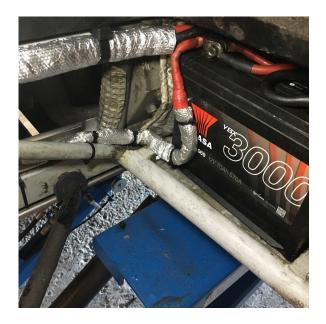
Anderson connector as removed from a 2001 Tuscan. Heavy corrosion on both terminals and casing disintegration. Danger of short circuit leading to electrical fire and/or moisture causing battery to discharge.
