Overhauling a TVR Aluminium Steering Rack

The rack I overhauled was a Tamora rack which I will be swapping with my Cerbera rack due to excessive play in the central position. As far as I'm aware essentially all the aluminium racks are the same which I will be able to confirm once my rack is out of my car.

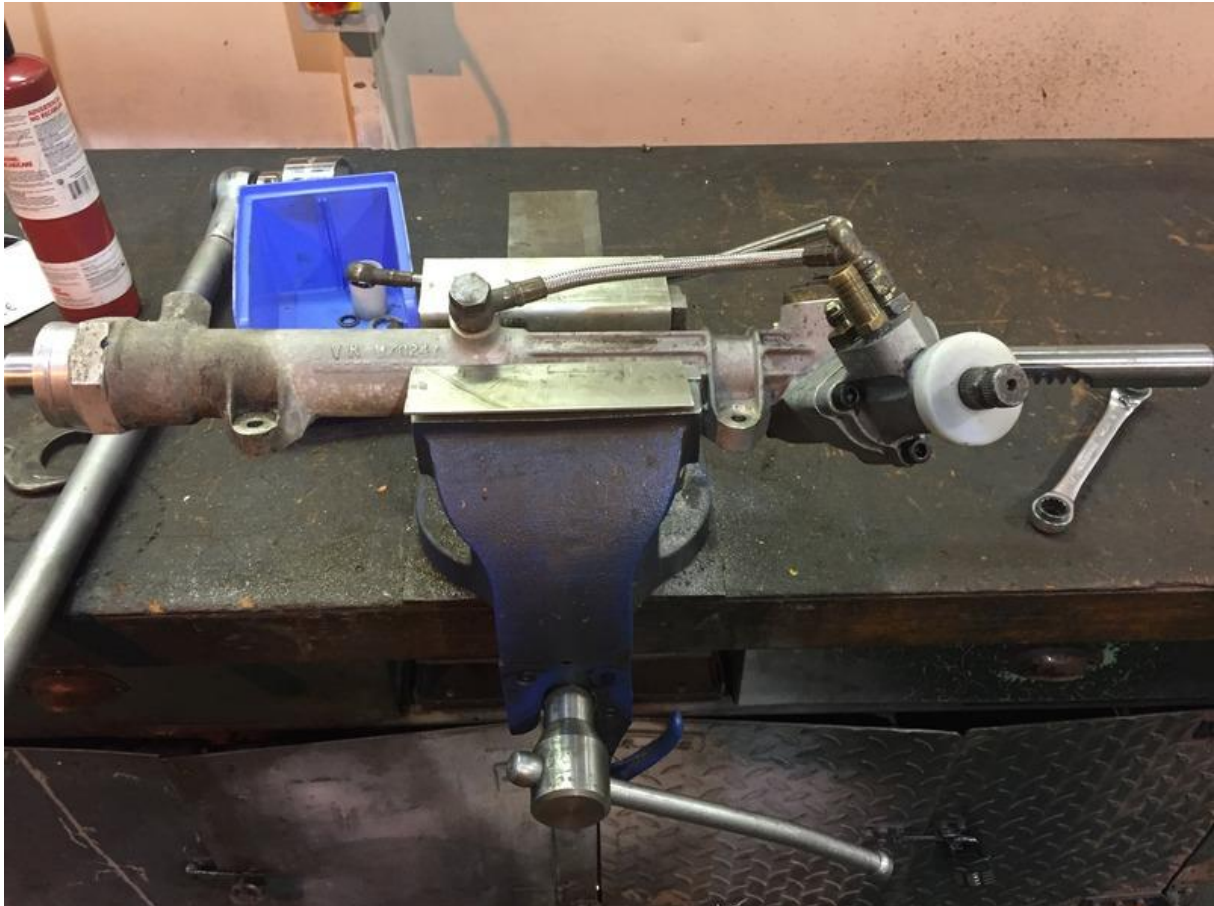
This is the rack in question.

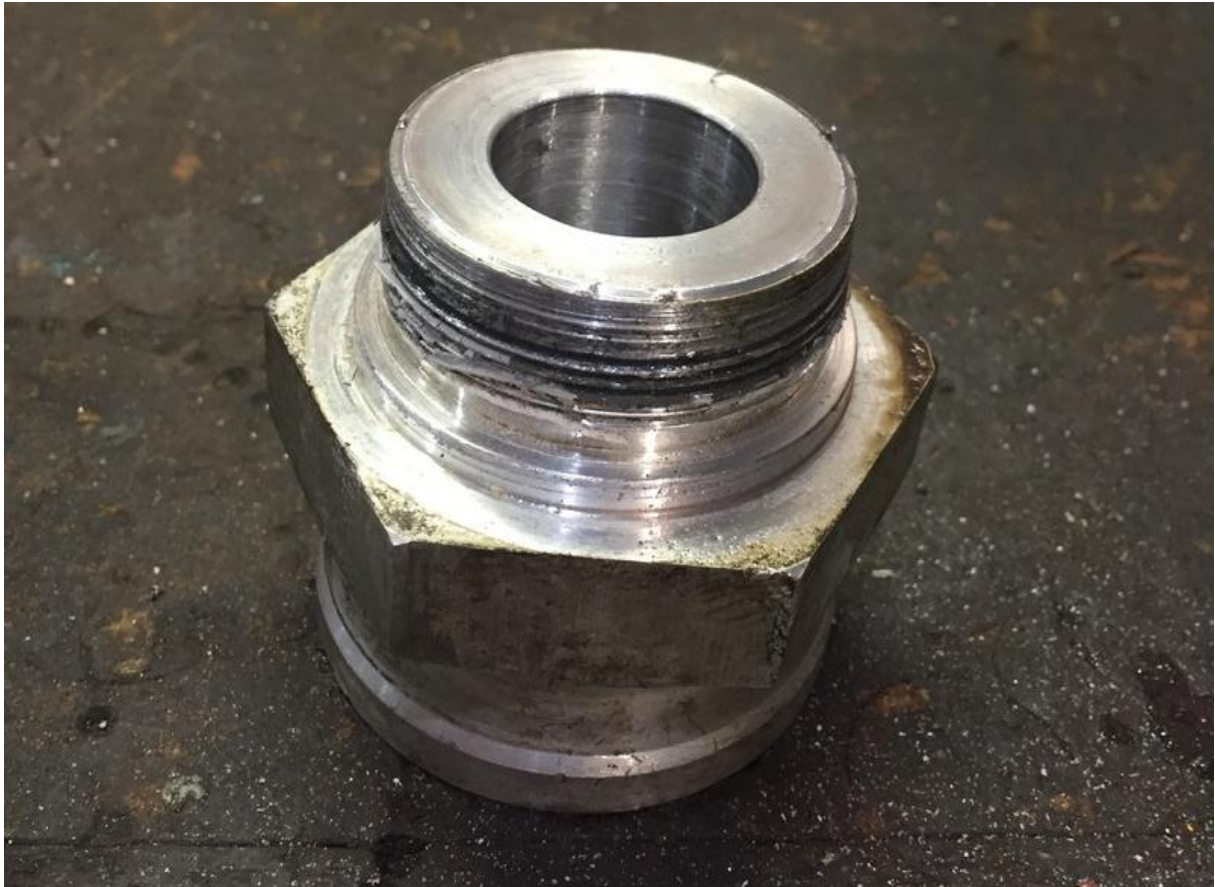
The big end nut, which has one of the seals in, mind did bind up as you can see, even with heating the nut up to loosen the sealant. Easily removed with a 60mm socket and ratchet.

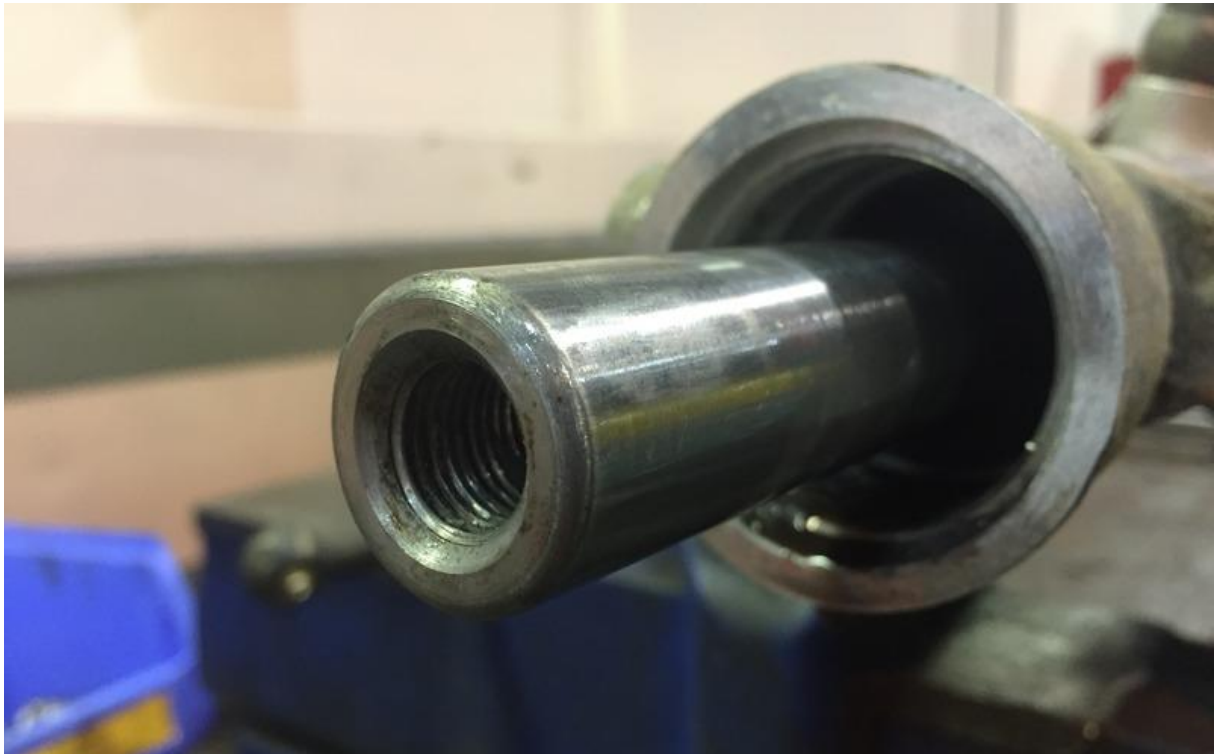
End of rack bar where the big nut is.

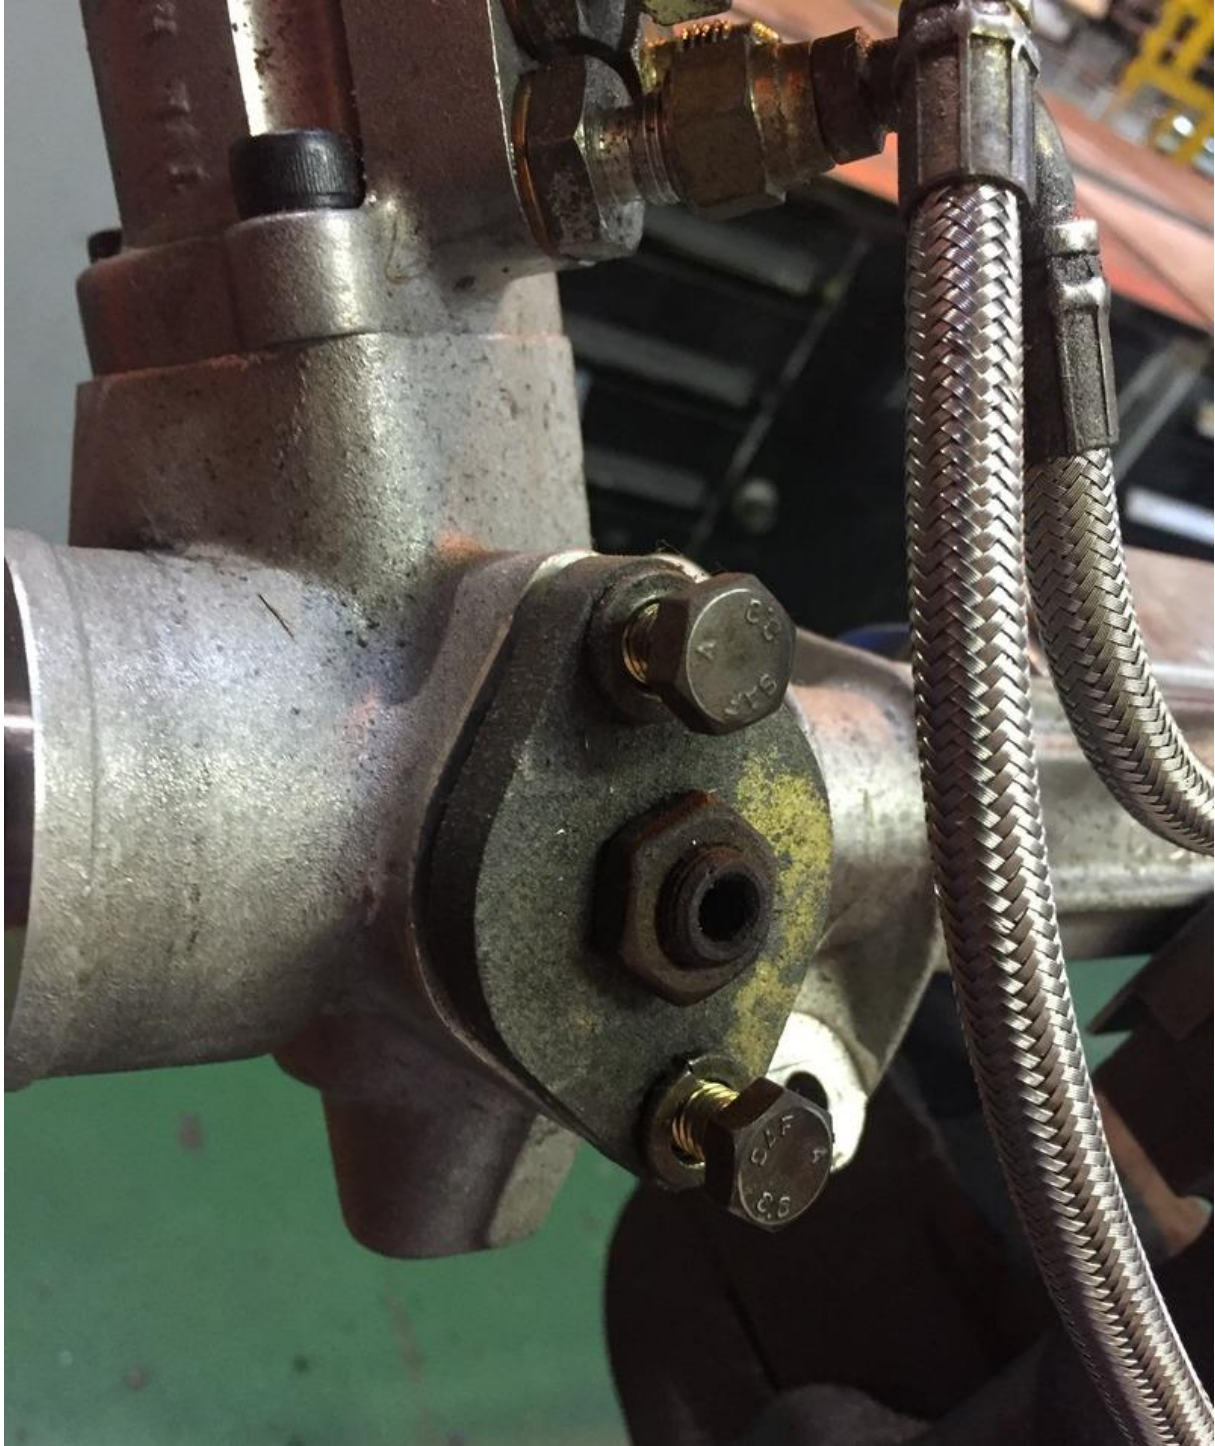
Adjuster plate for adjusting out any slop in the rack, but only works for an amount of time before parts need replacing.

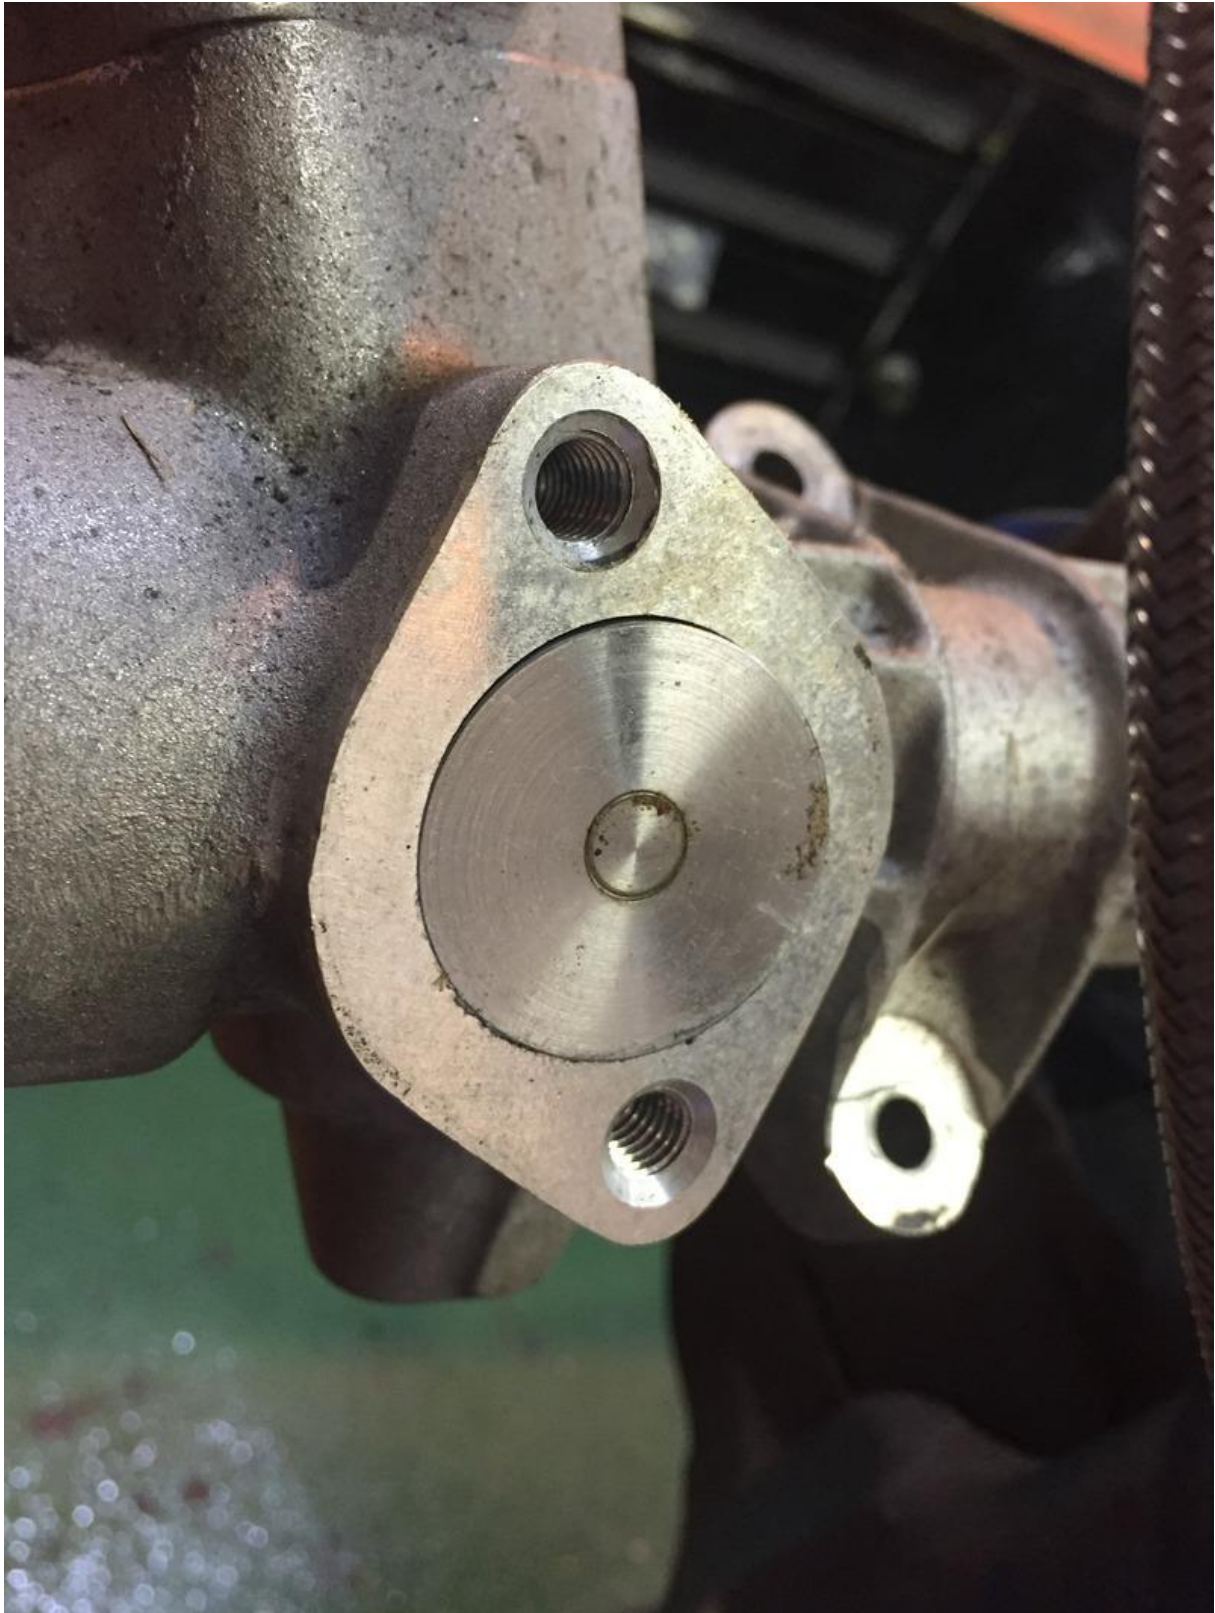
Inside of adjuster pressure plate.

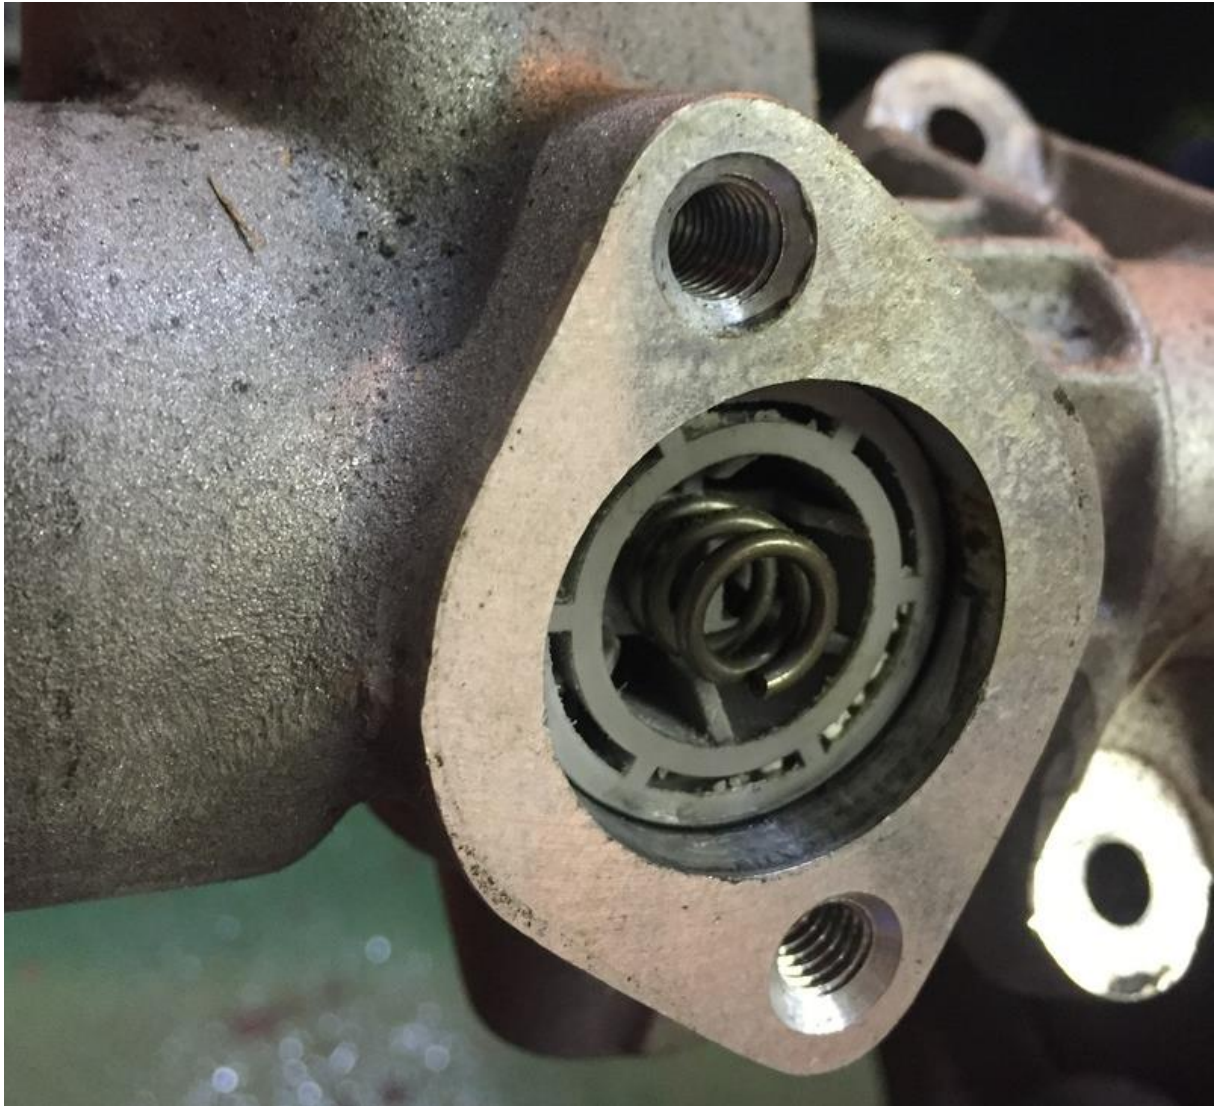
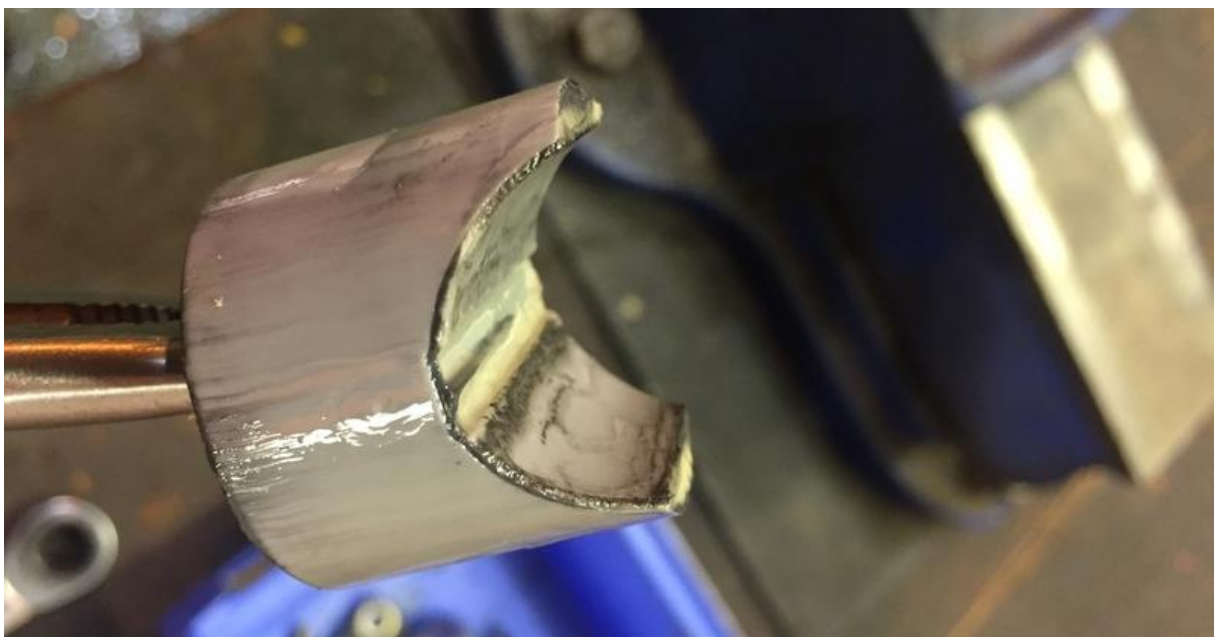
Spring and nylon guide.

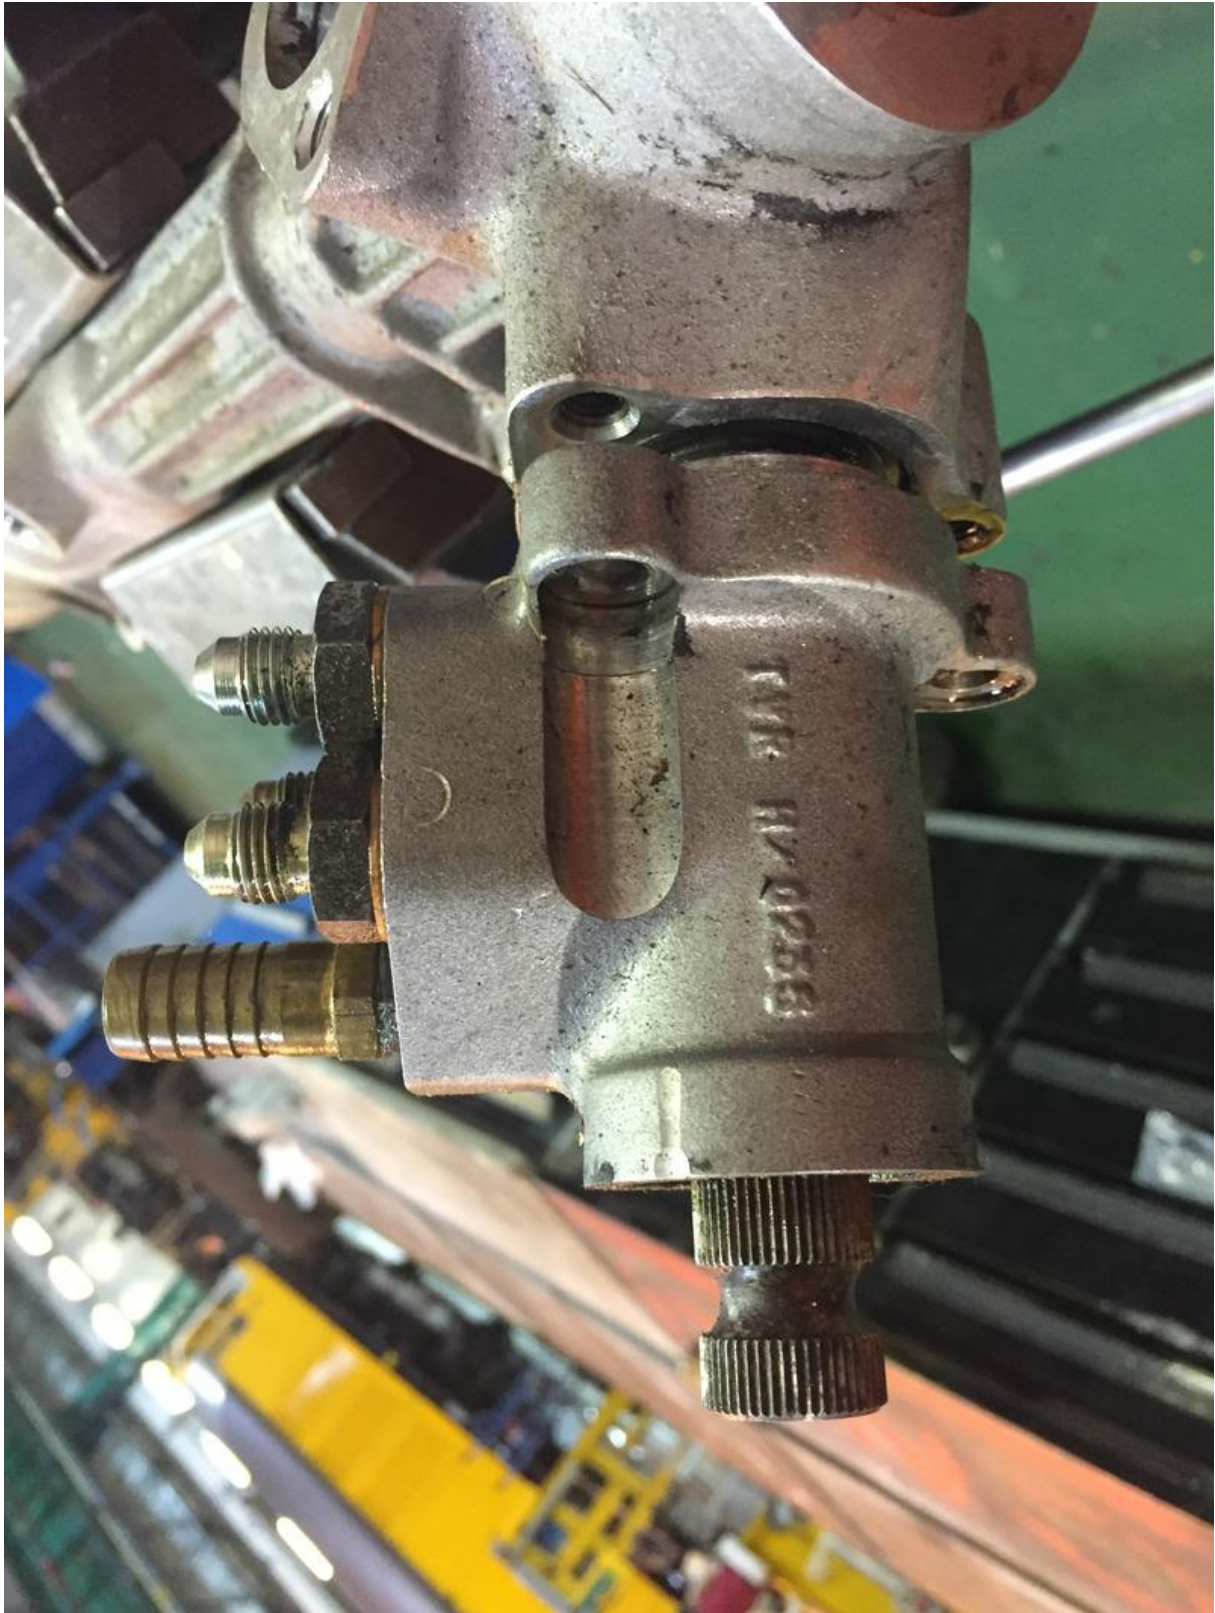
Valve body held on with Three M8 bolts.

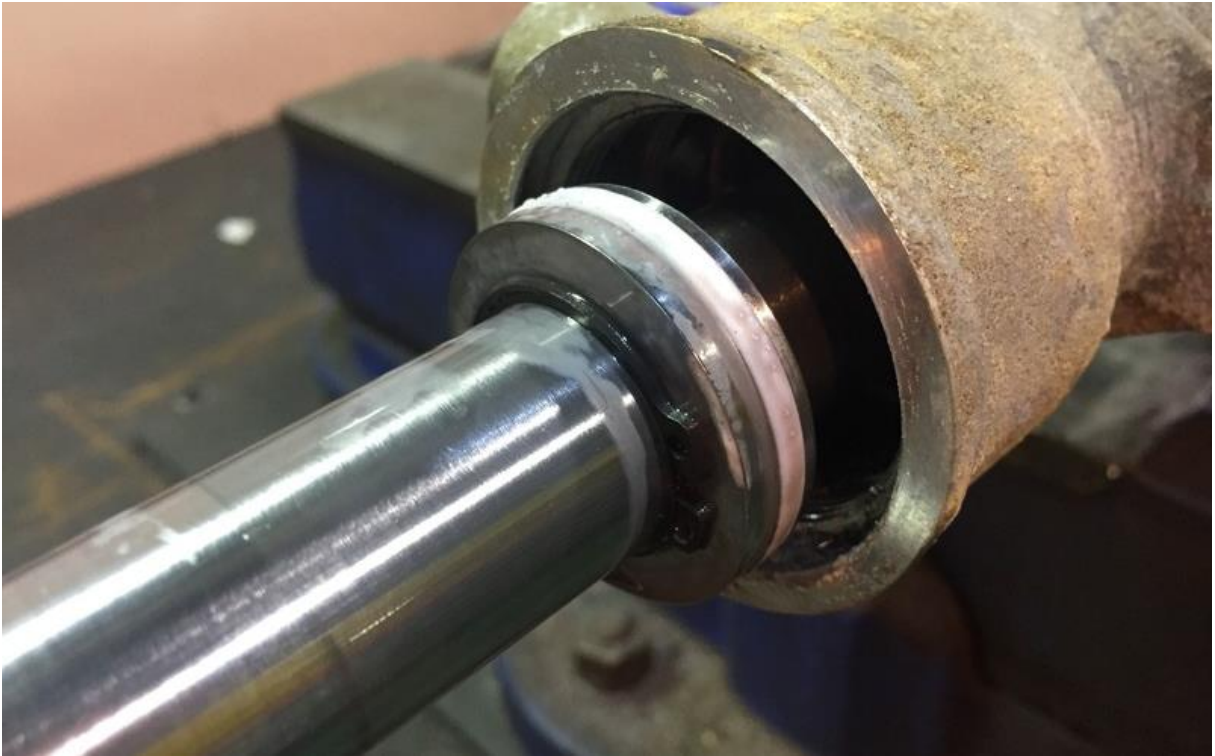
Rack bar seal, the white seal is sandwiched between the two plates with an O ring inside.

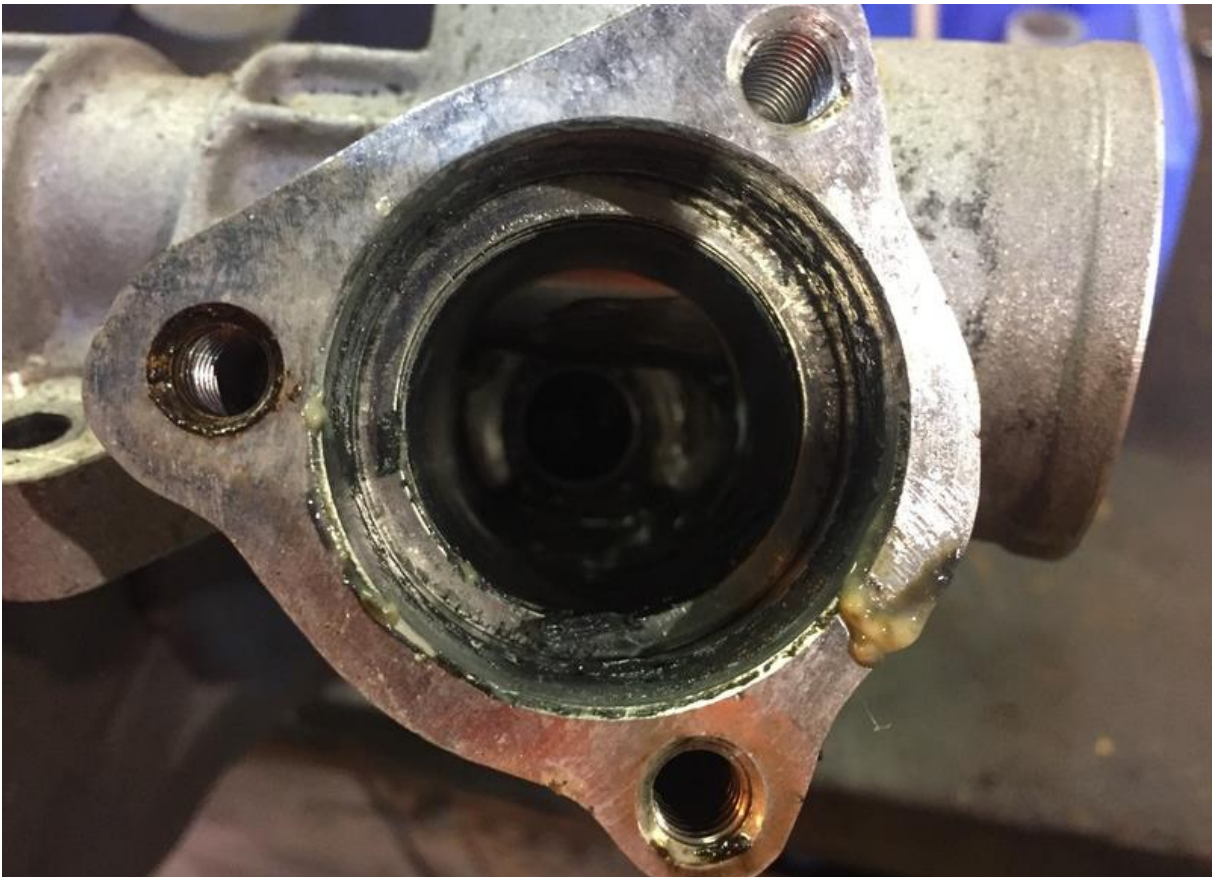
Valve body mounting to the rack body, there are shims placed between the valve body and rack, you can just about make out the needle bearing.

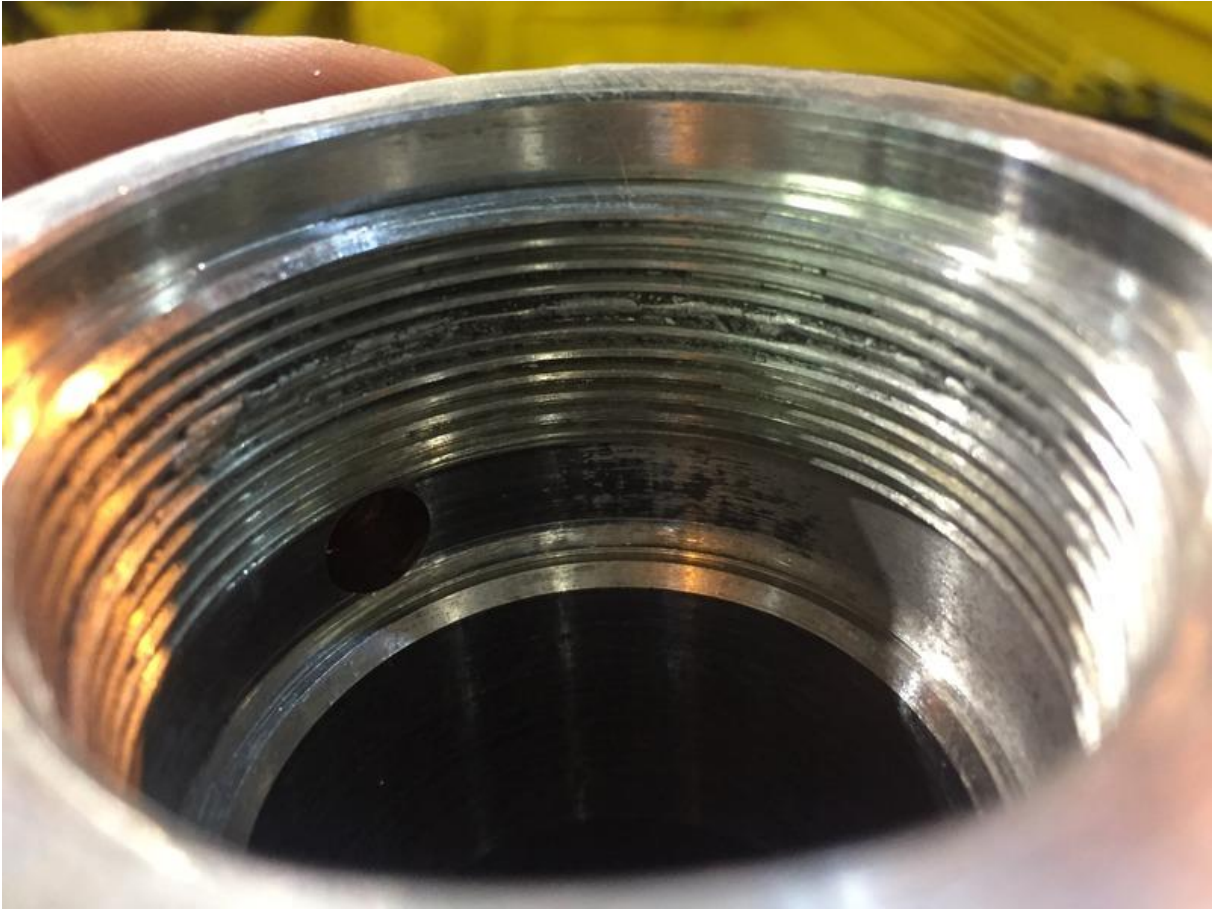
Rack body showing the threaded end where the big nut goes shows some of the aluminium where it had bound up.

To clean out the threads i used a thread file, but in the end i had to use get a 45 x 1.5mm tap to get the threads correct as even after using the file the new big nut got tight to early.

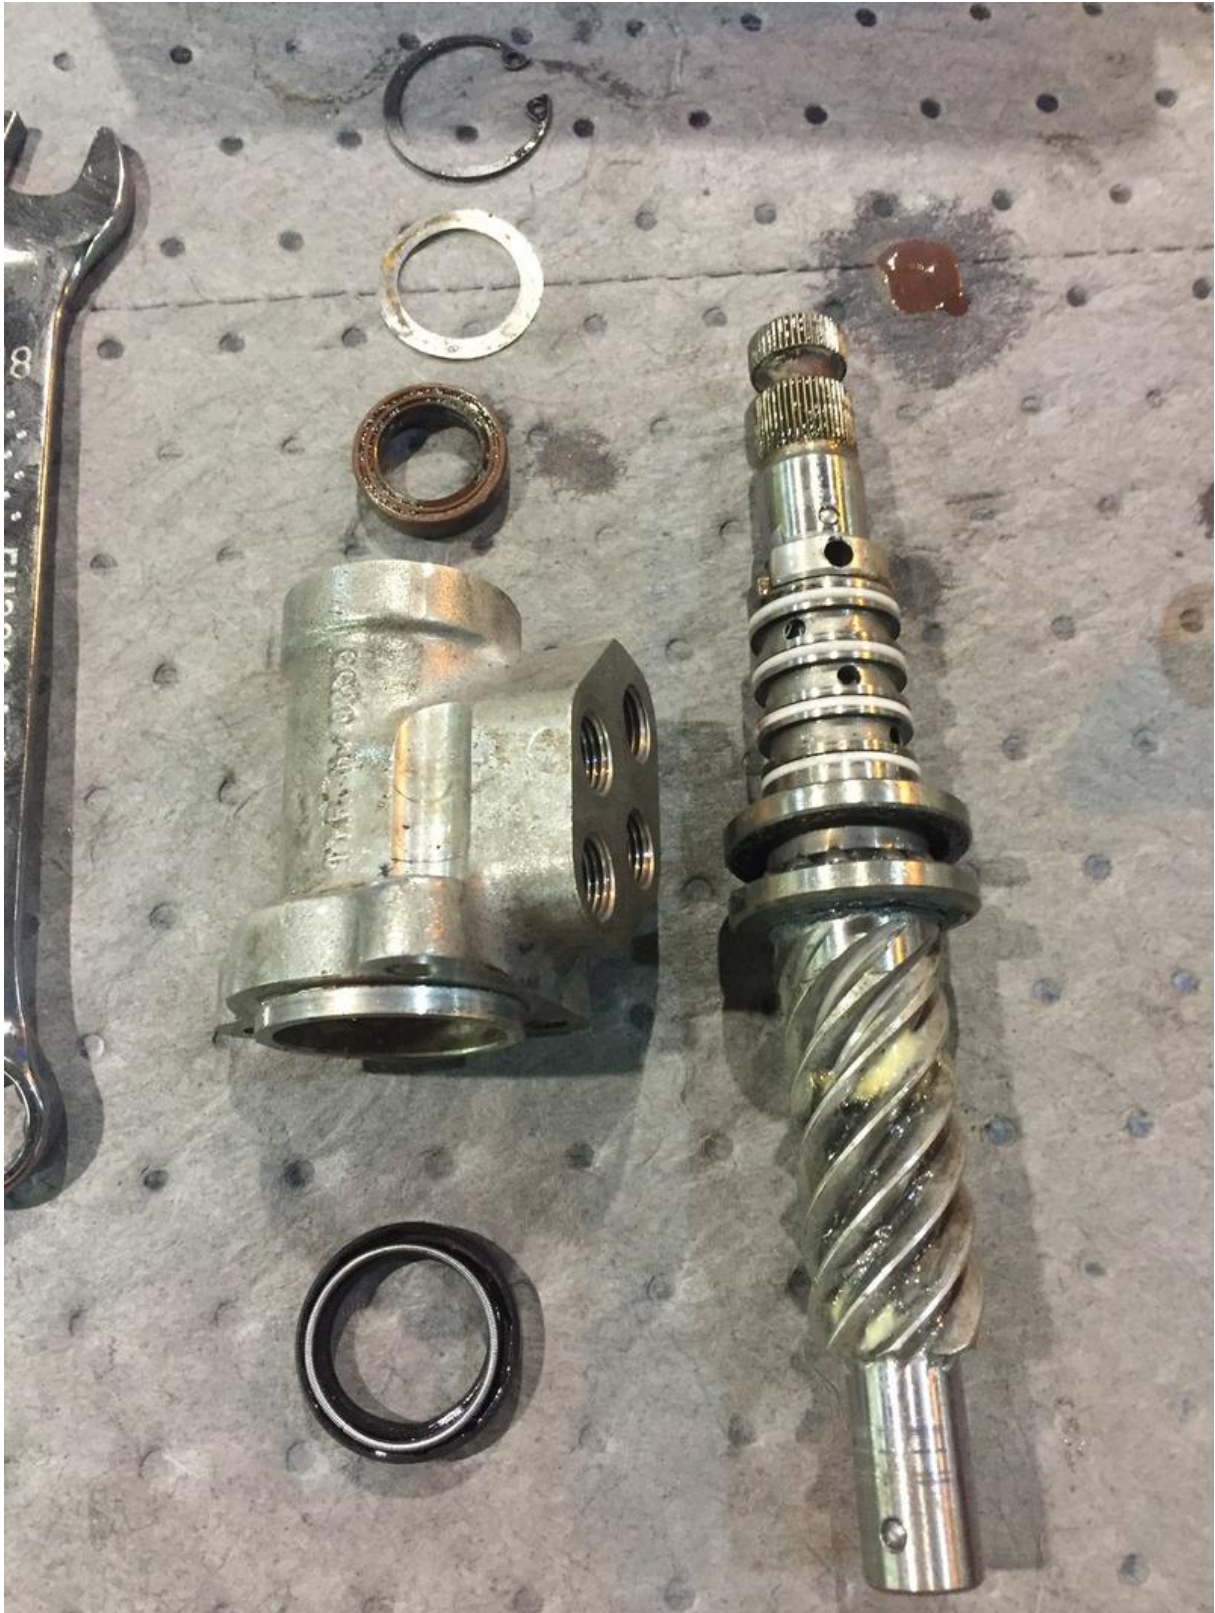
Valve body, pinion, seals in order.

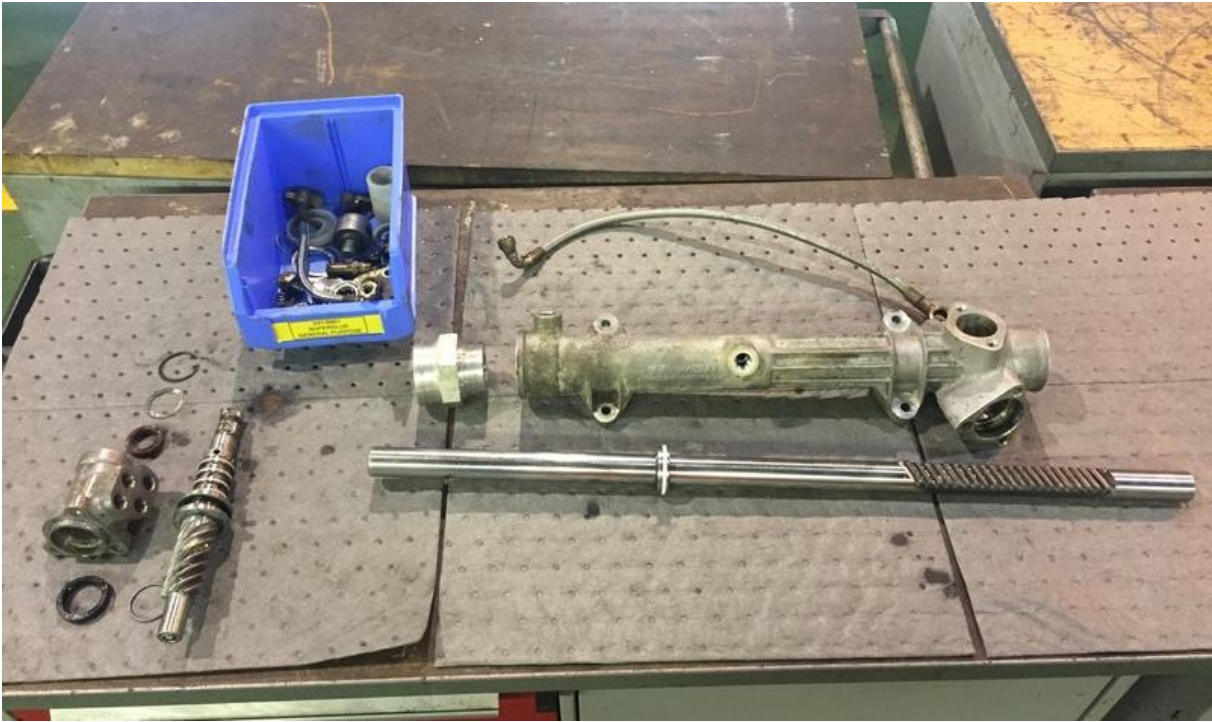
Rack exploded after complete strip down.

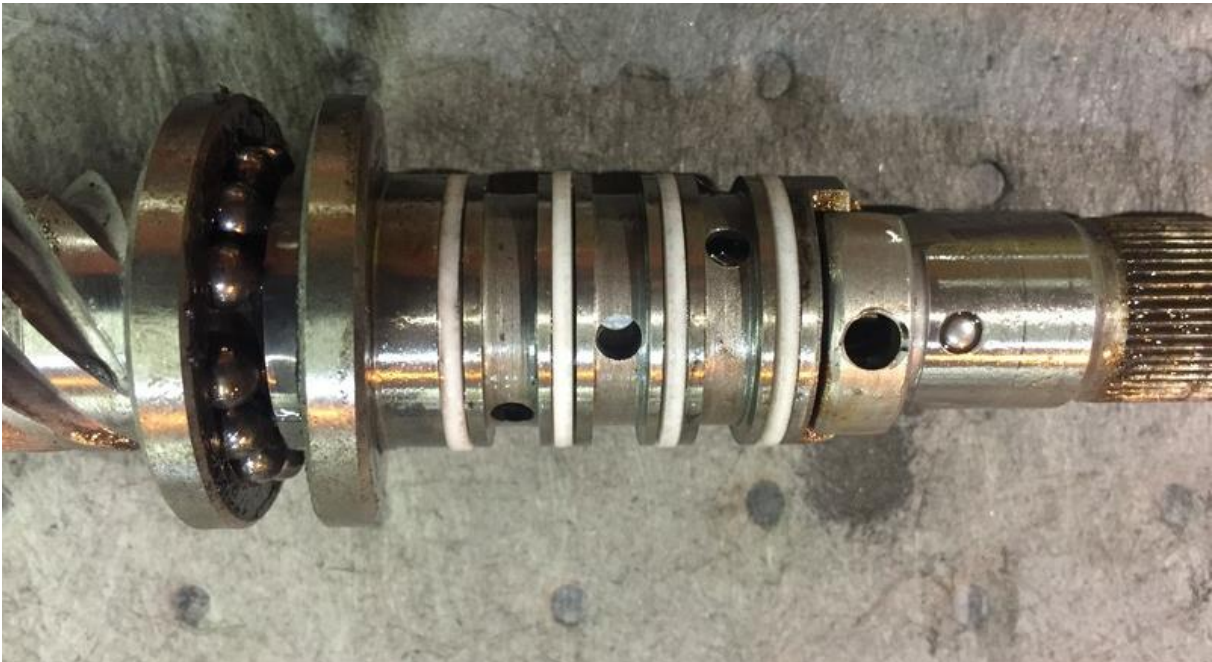
Seals on the pinion, and bearing.

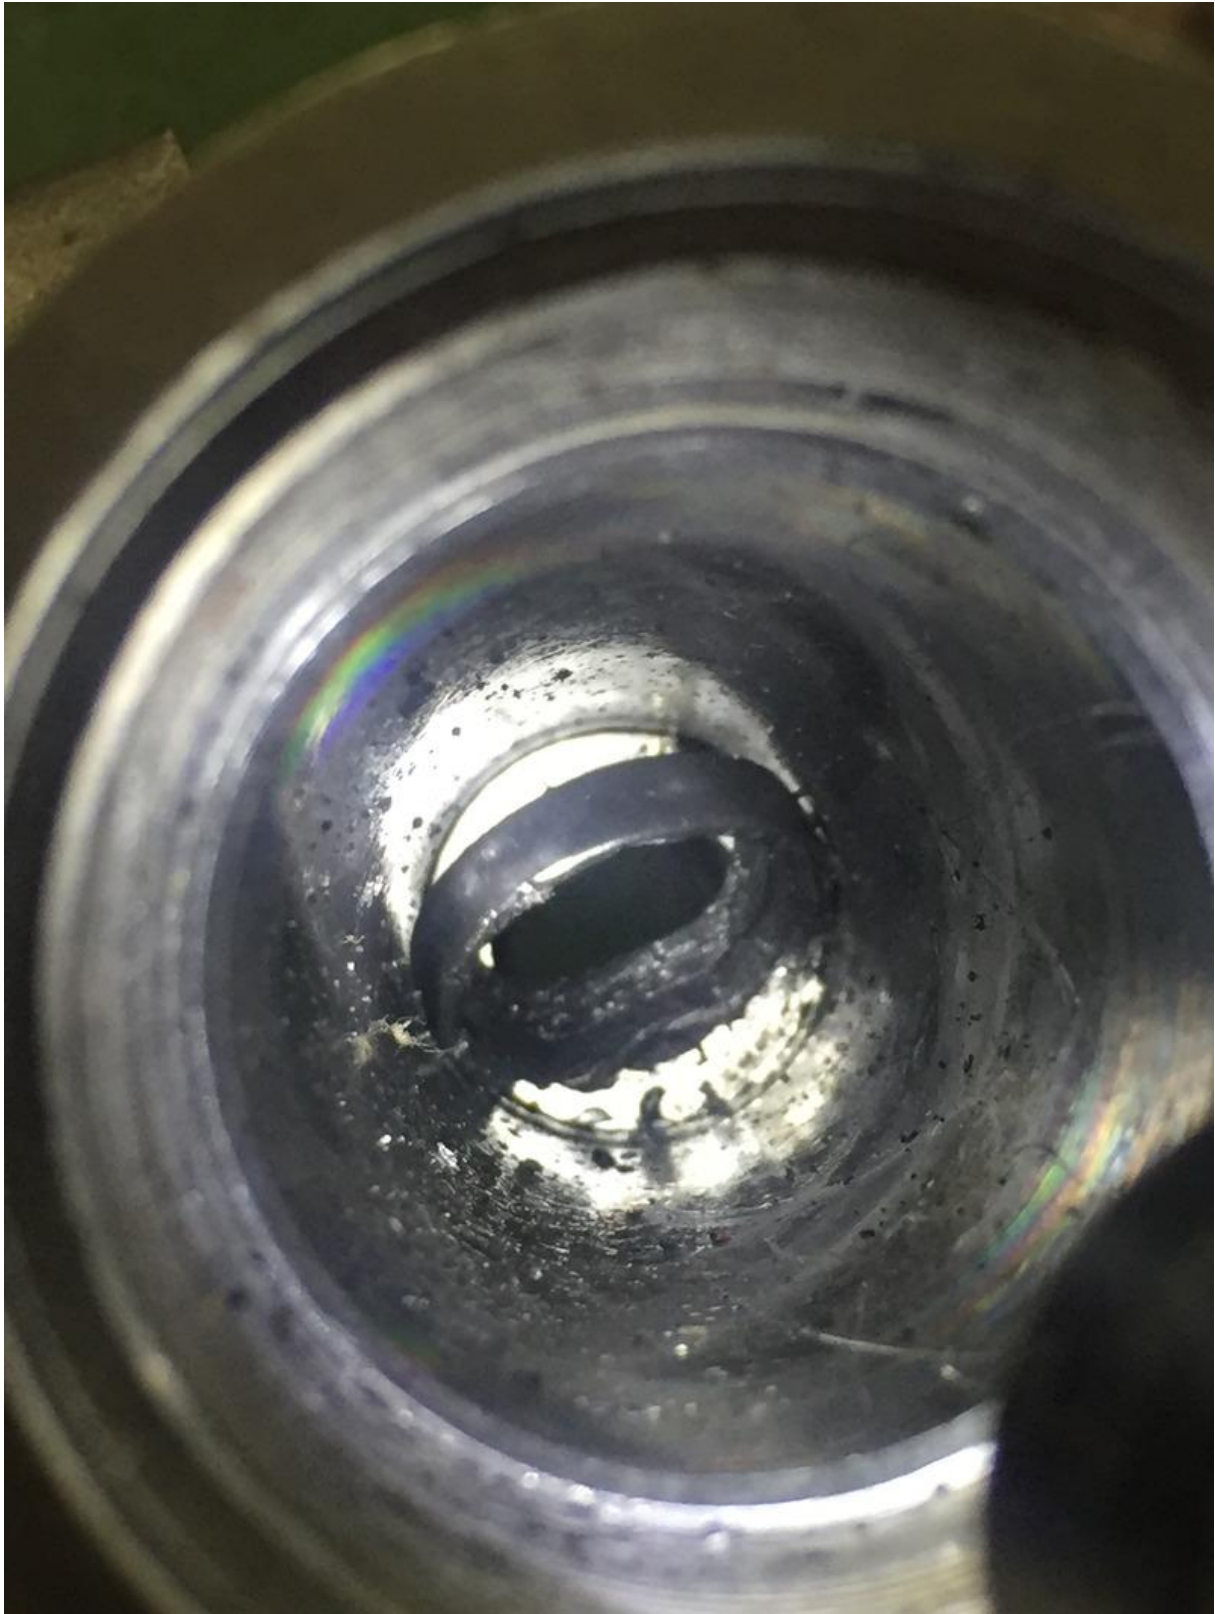
Looking into the bore of the cylinder end of the rack with the inner seal, pain to remove, I tried an internal bearing puller with uses a slide hammer, there is nothing to grip onto even from the other end, in the end, i chiselled the sides in not very elegant I know with some marking of the bore which I cleaned up by polishing the bore

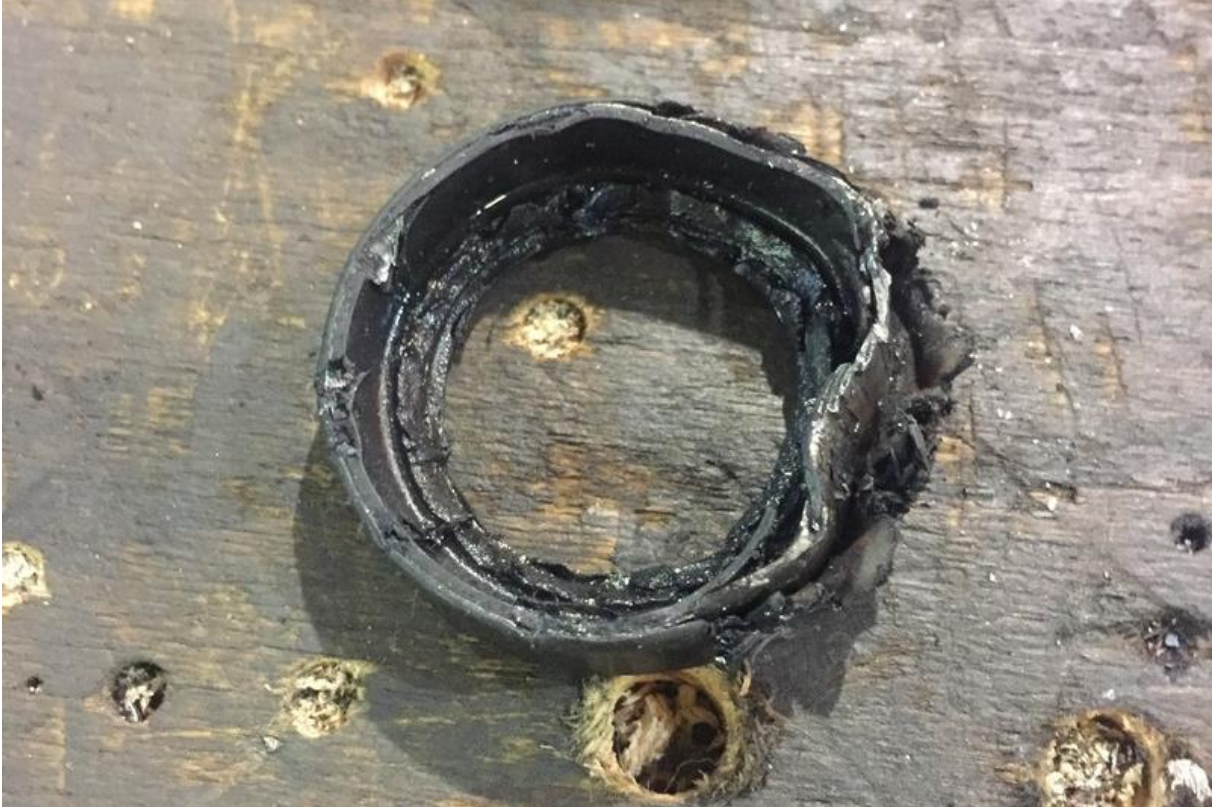
I did try heating the cylinder to see if expanding would work, also burning it out which neither worked.

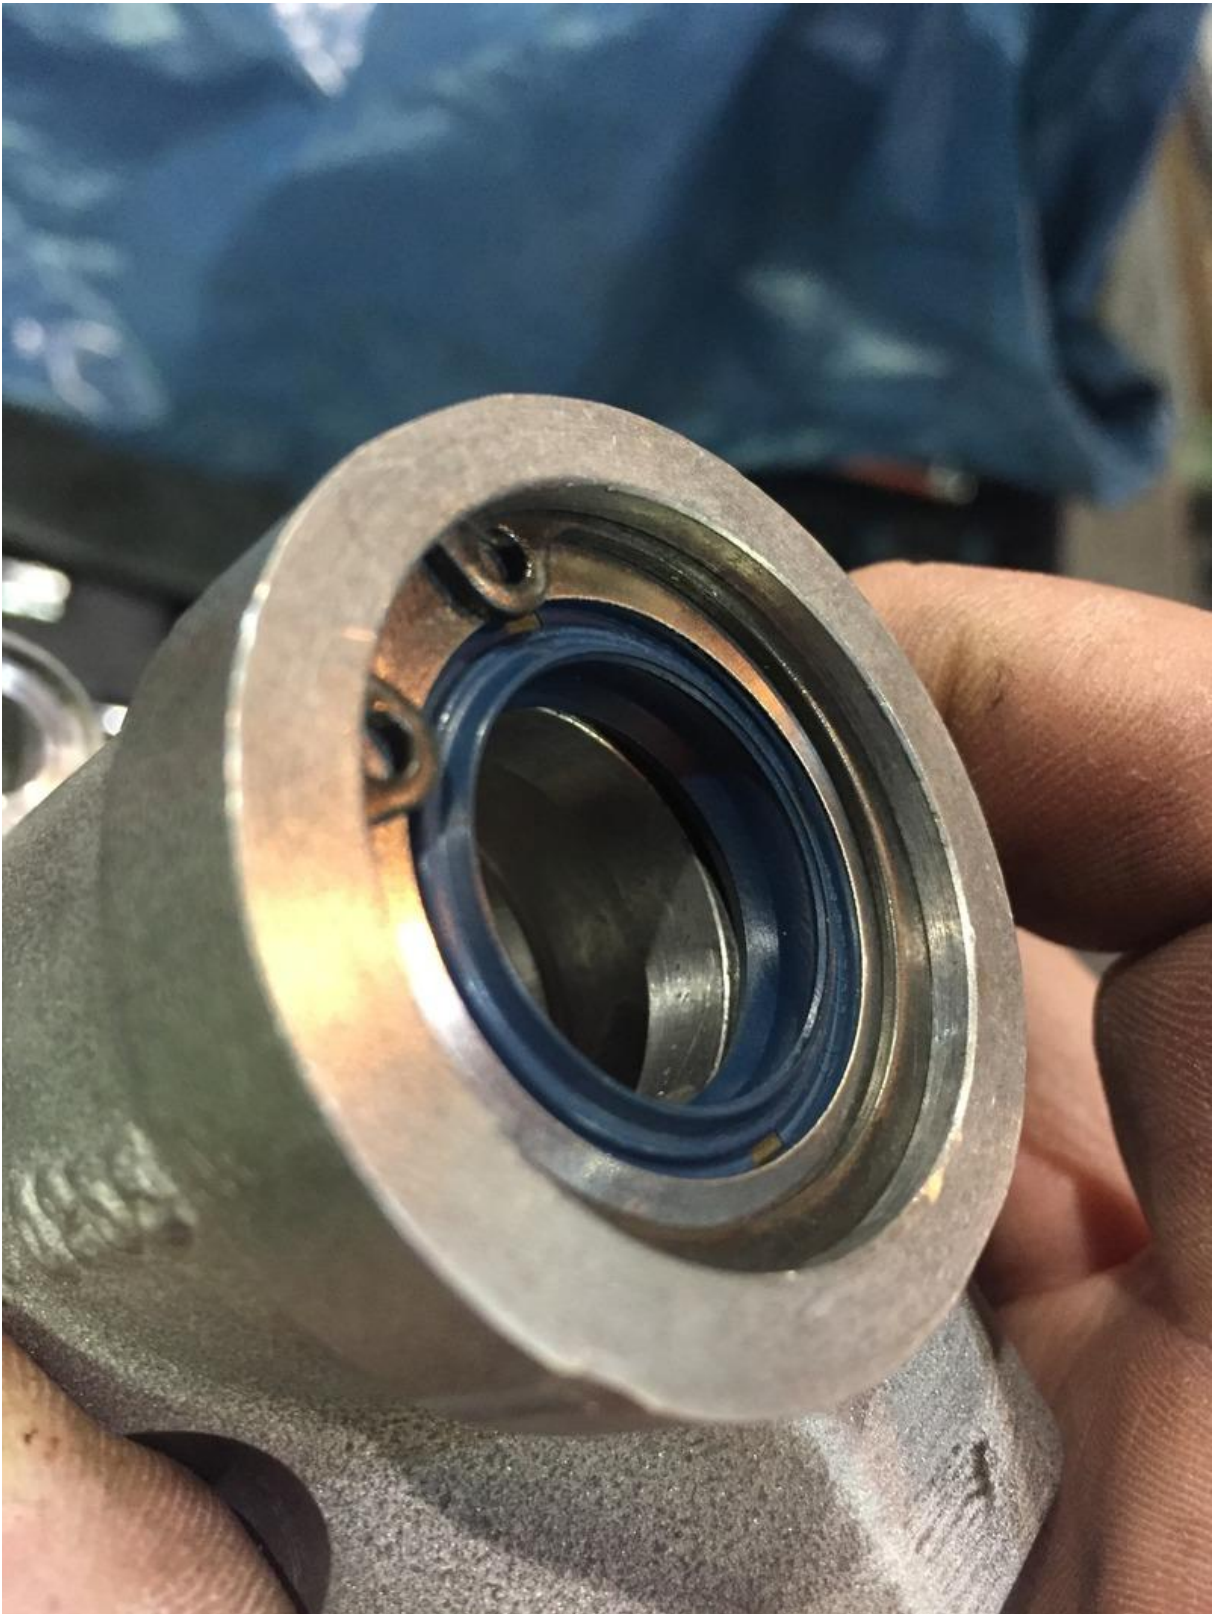
New seal in the valve body with the shim and circlip refitted this is the spline end.
