Overhauling a TVR Aluminium Steering Rack

The rack I overhauled was a Tamora rack which I will be swapping with my Cerbera rack due to excessive play in the central position. As far as I'm aware essentially all the aluminium racks are the same which I will be able to confirm once my rack is out of my car.

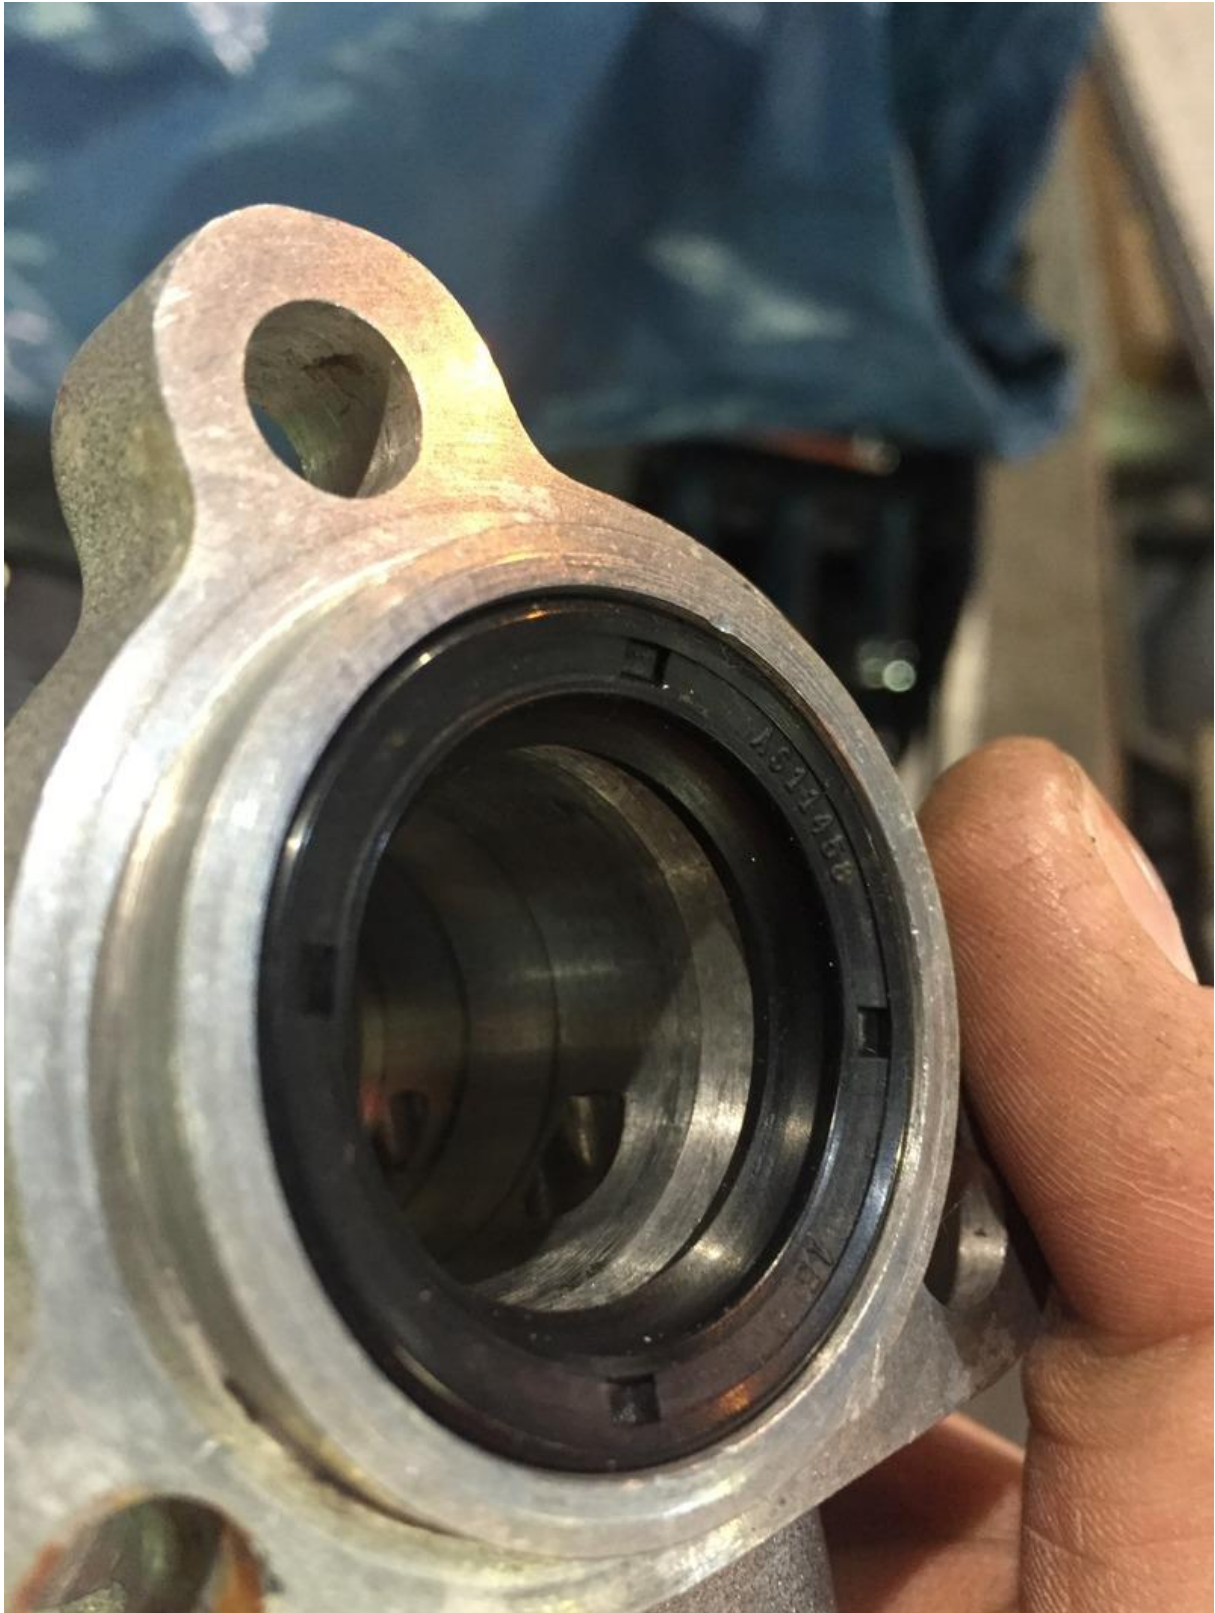
Valve body lower seal.

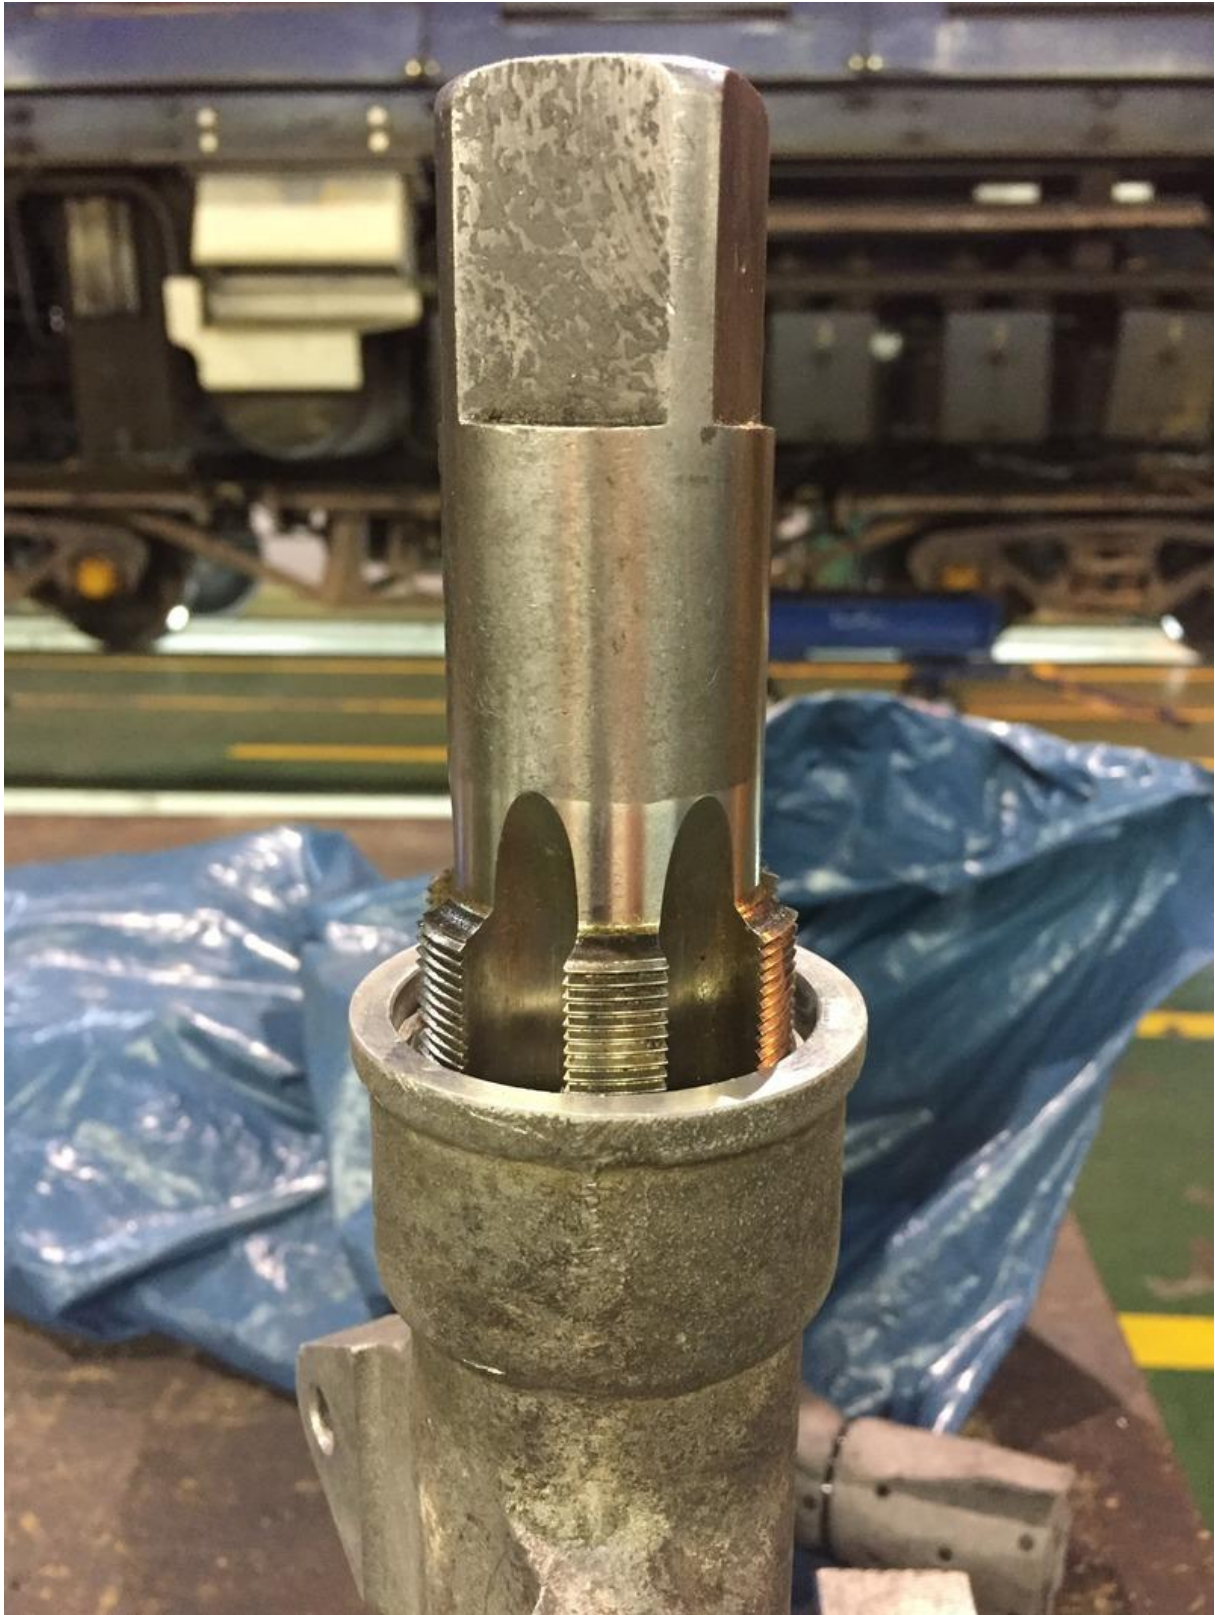
M45 x 1.5mm tap, was lucky to find a used one for £50 new they are £200, I searched high and low to find one at work and nothing did the job.

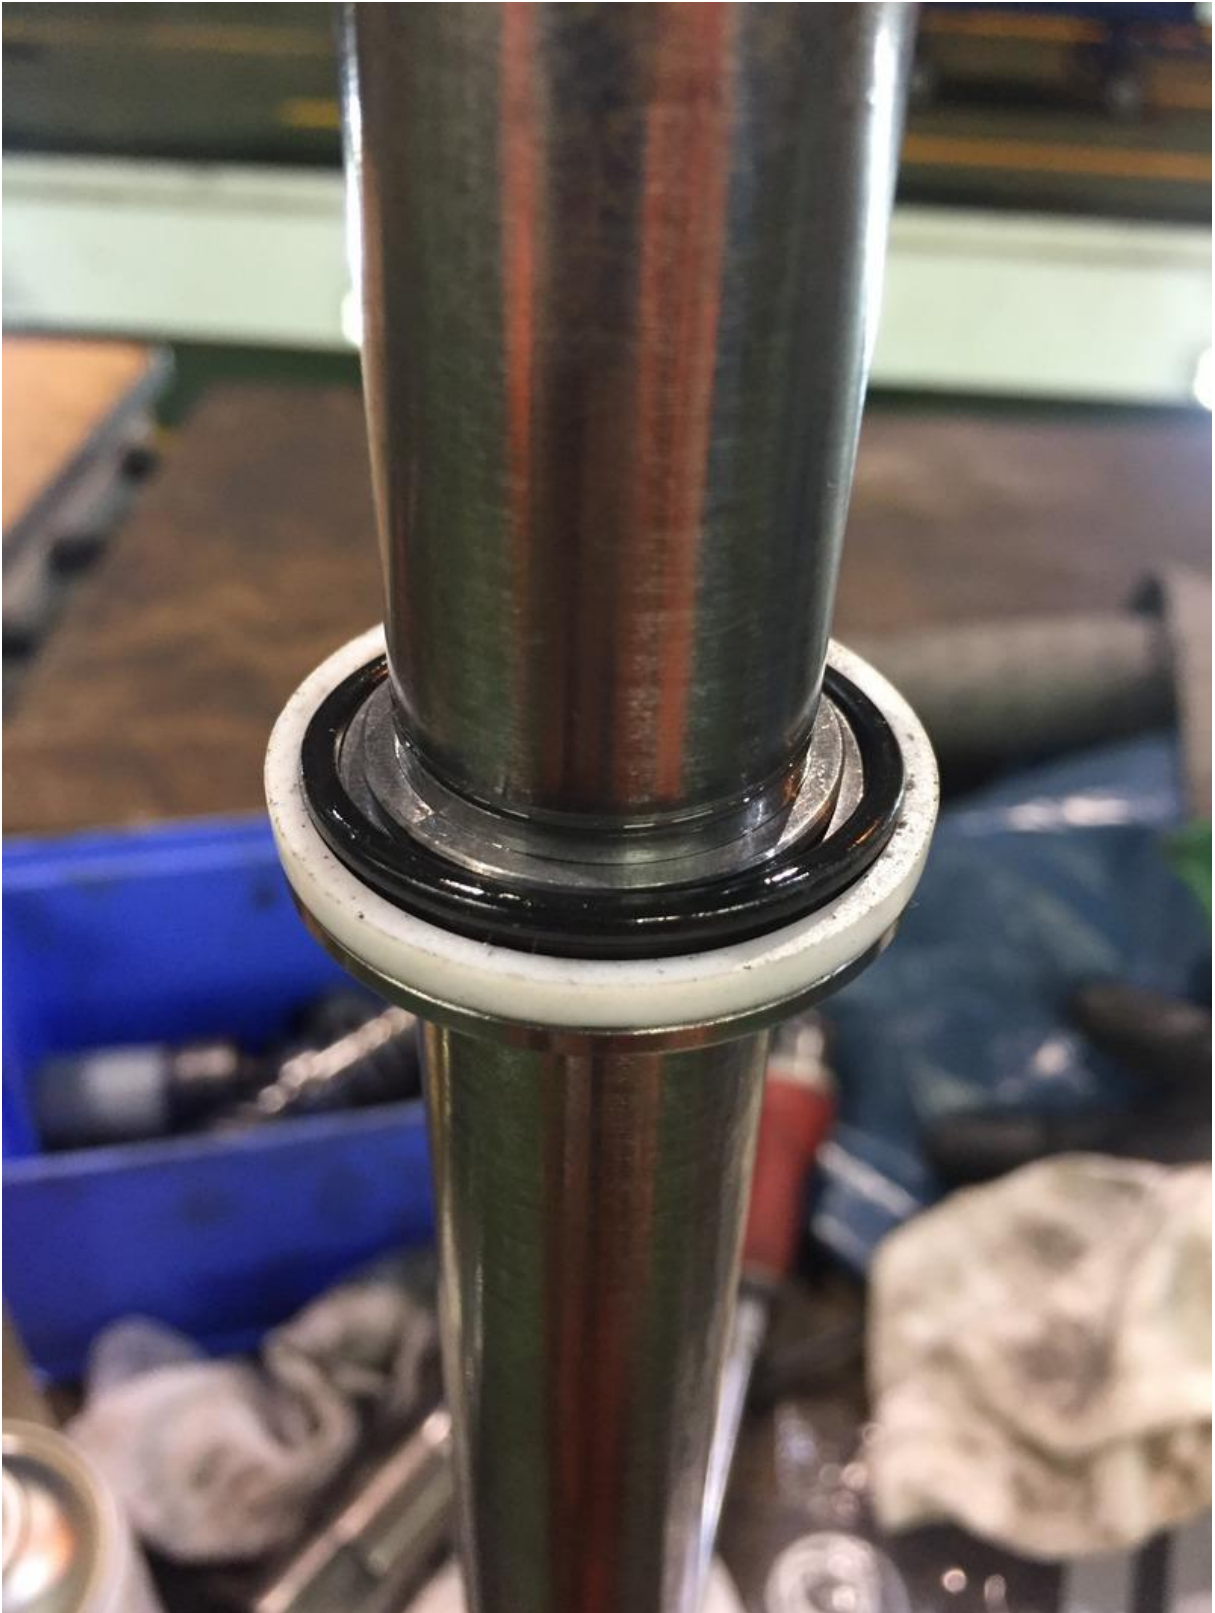
Rack bar seal minus the top plate and circlip, showing O ring and PTFE seal.

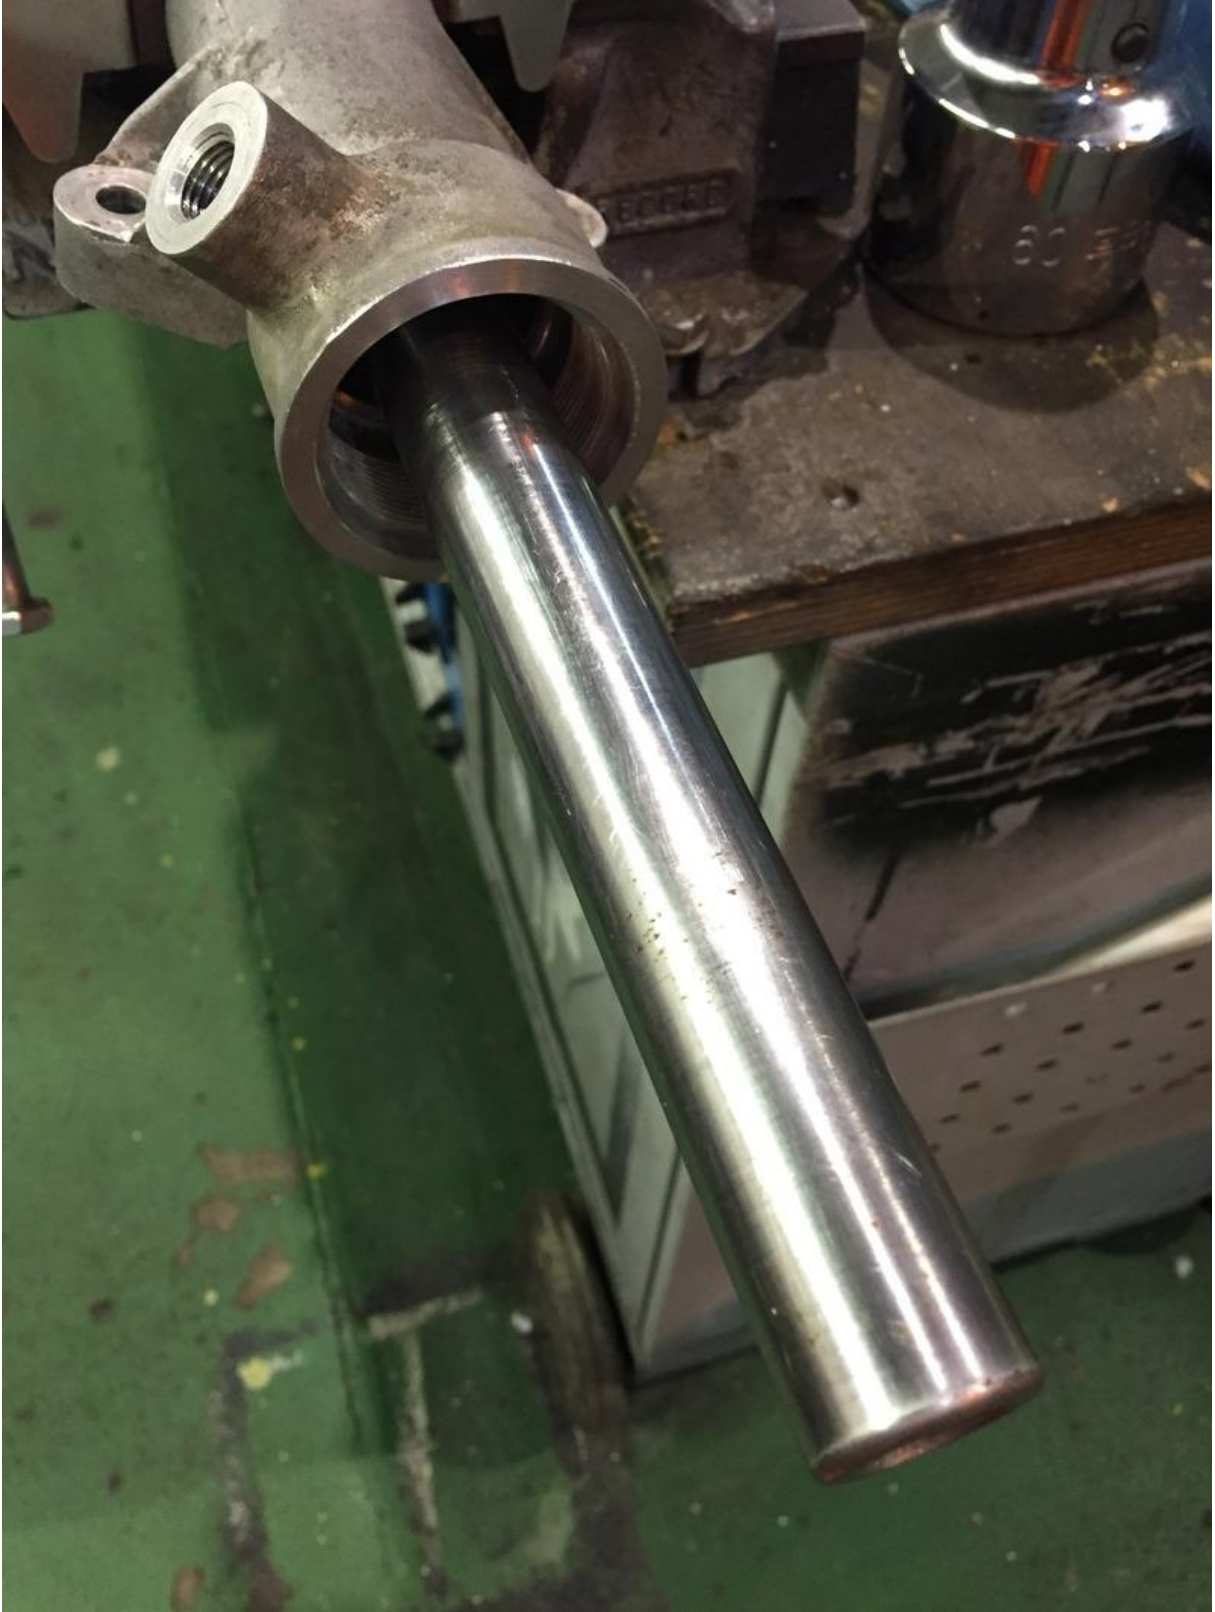
I put the new inner cylinder seal in with a socket and extension bar, couple of taps with a copper hide mallet and seated nicely.

Rack bar back into the rack using some new ATF.

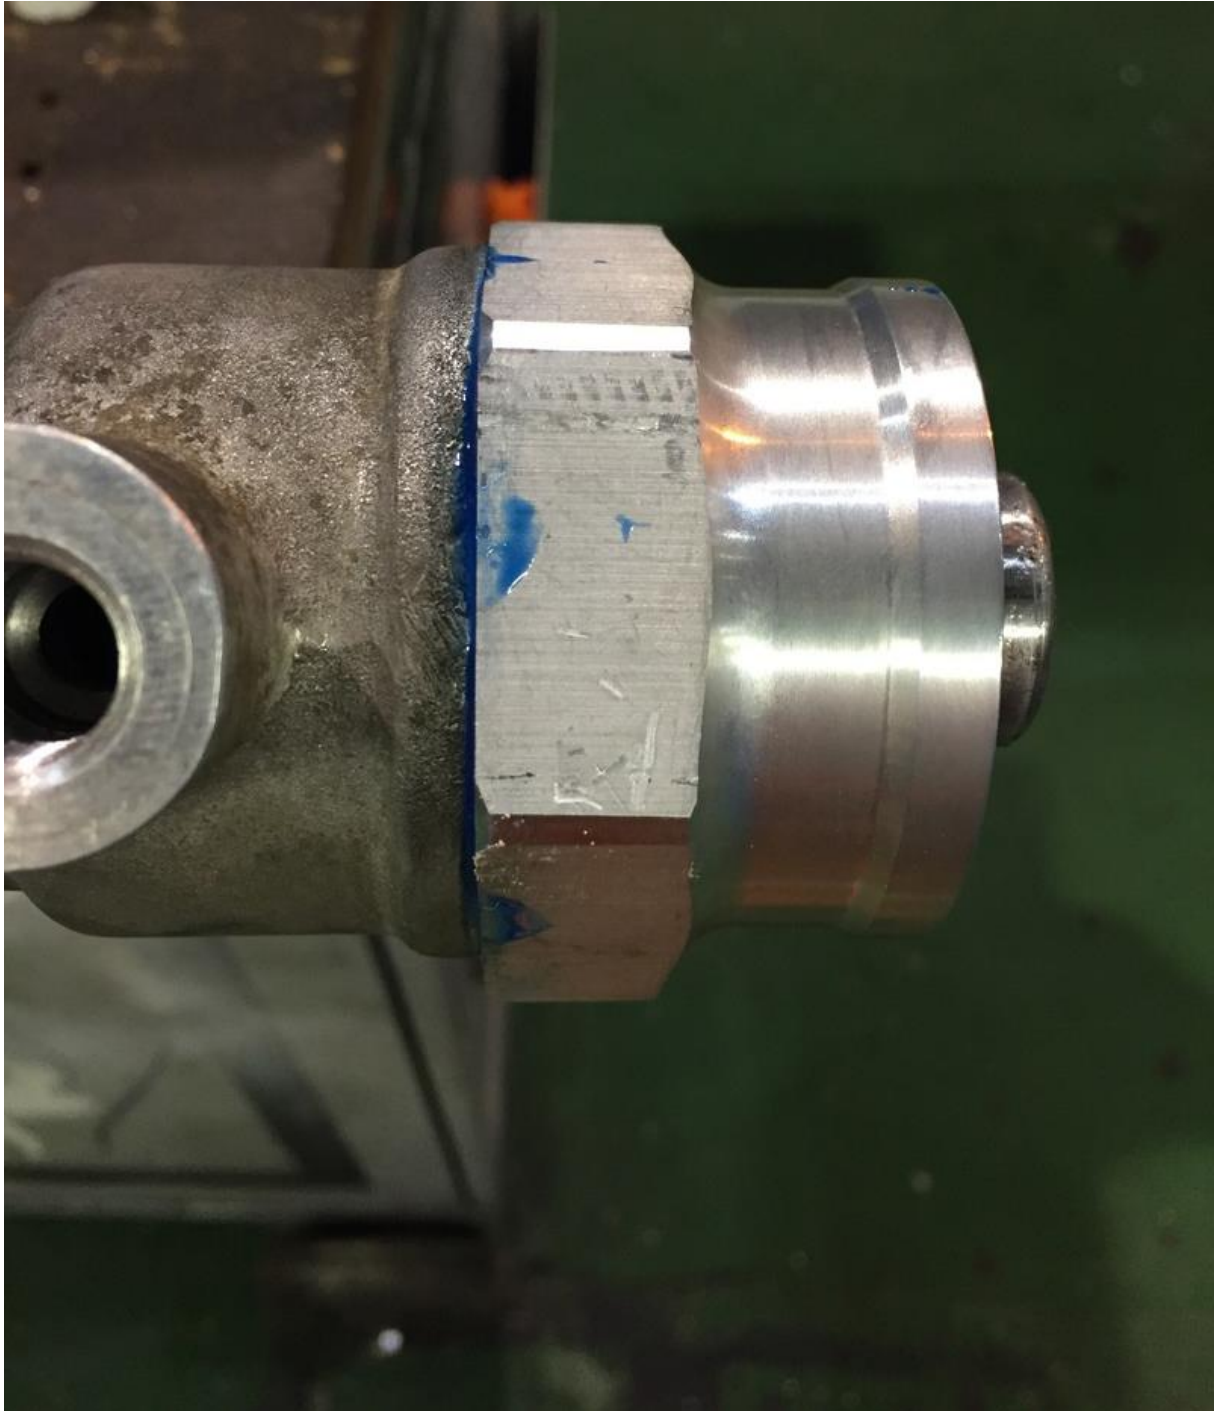
I spoke to Kiley Clinton where i was able to get a seal kit from £58 posted, they recommended Loctite 243, which luckily use at work, i did ask for a torque setting but they only told me nipped up which with a 60mm socket and foot and a bit racket nipped up is pretty tight.

I considered lots of ways to stop it binding in the future, but because of having to use a thread sealant you can't really use one, which may limit the amount of times a rack can be dismantled with it destroying threads.

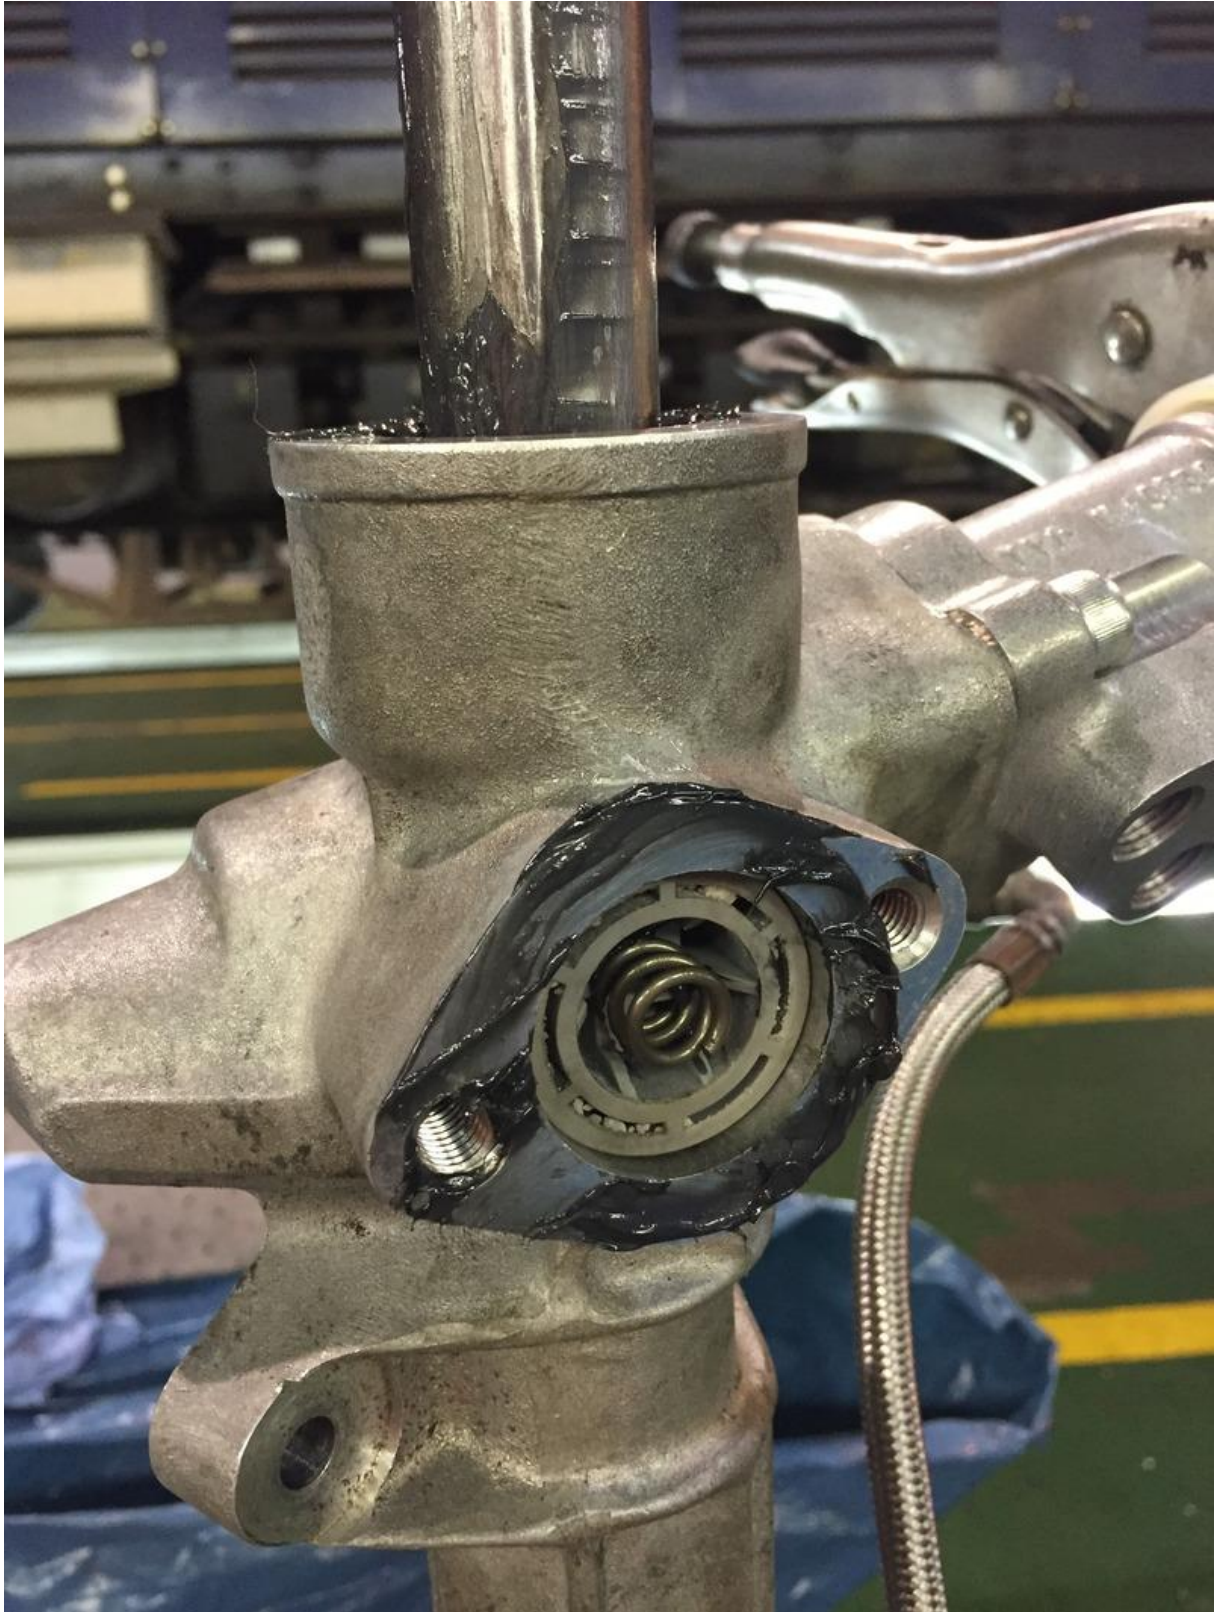
I assume part of the premature wear of the rack either the bar or pinion is part down to lubrication. I found when cleaning out the rack that they had used white lithium grease. I used cv lithium grease when rebuilding.

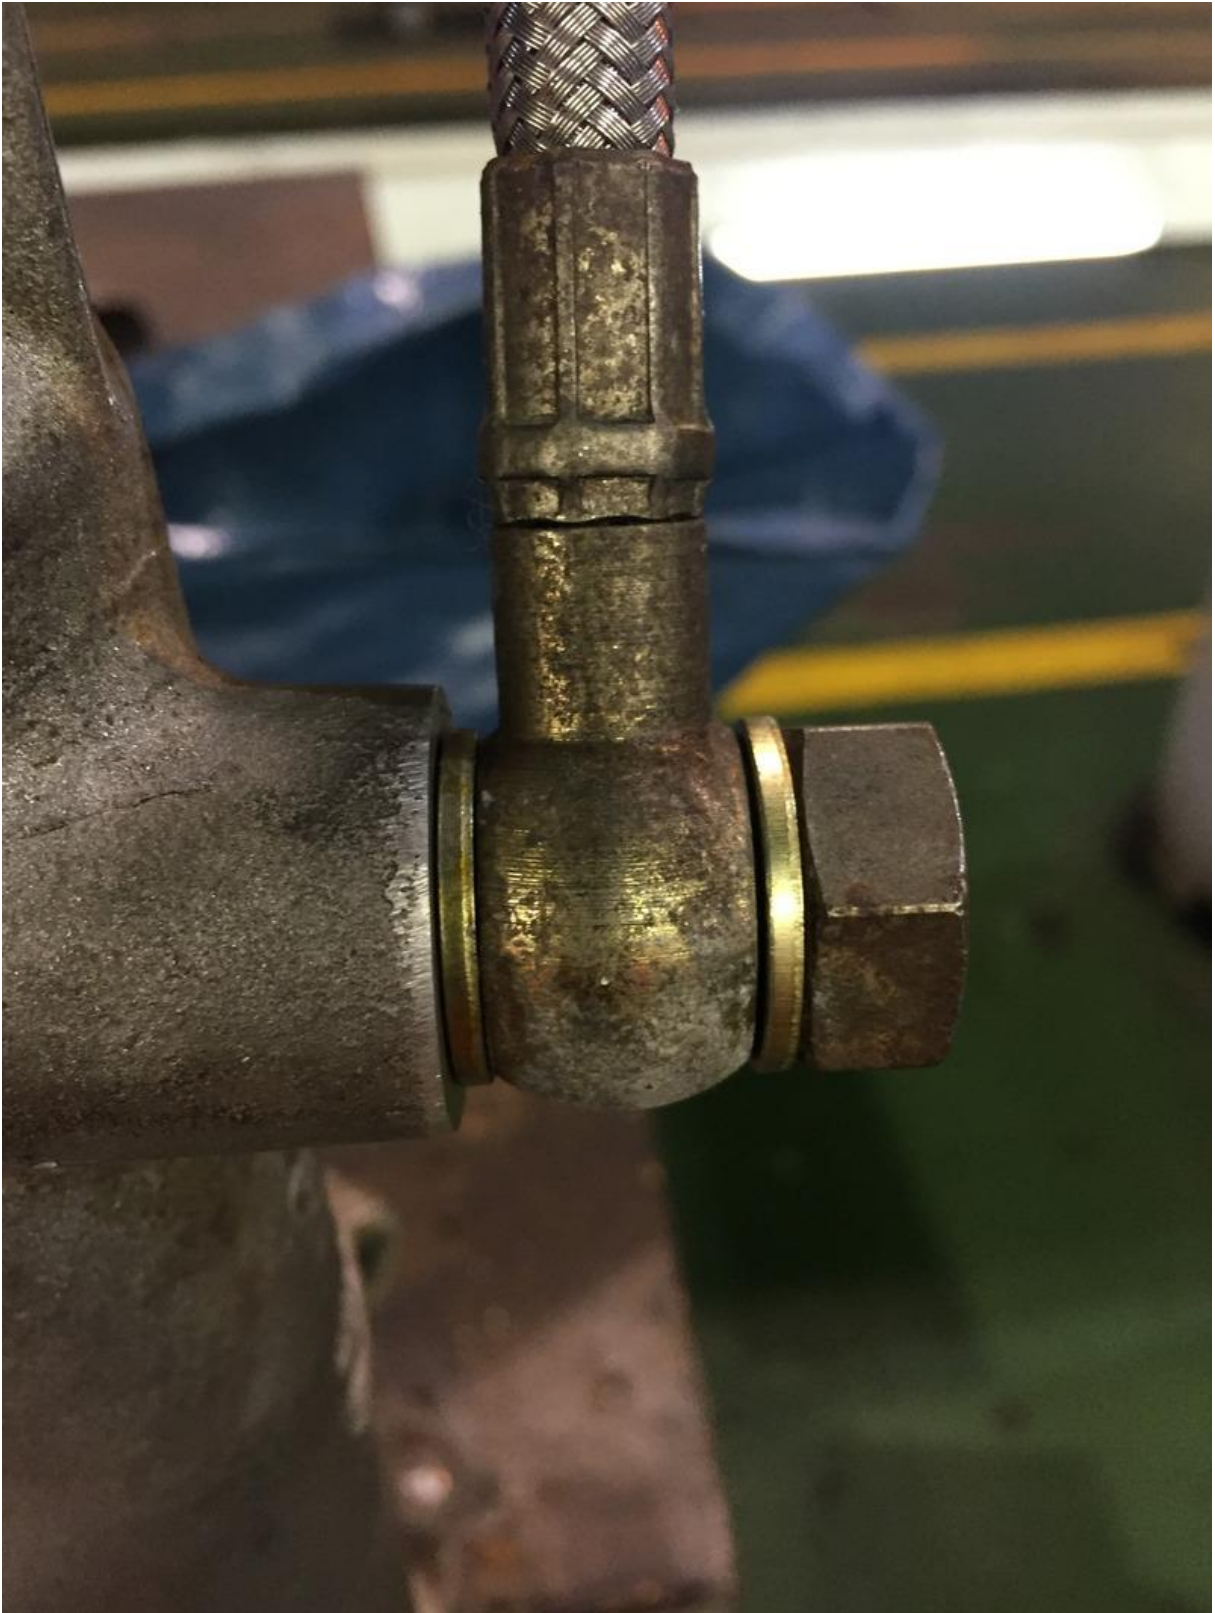
New Dowty washers between the banjo bolts.

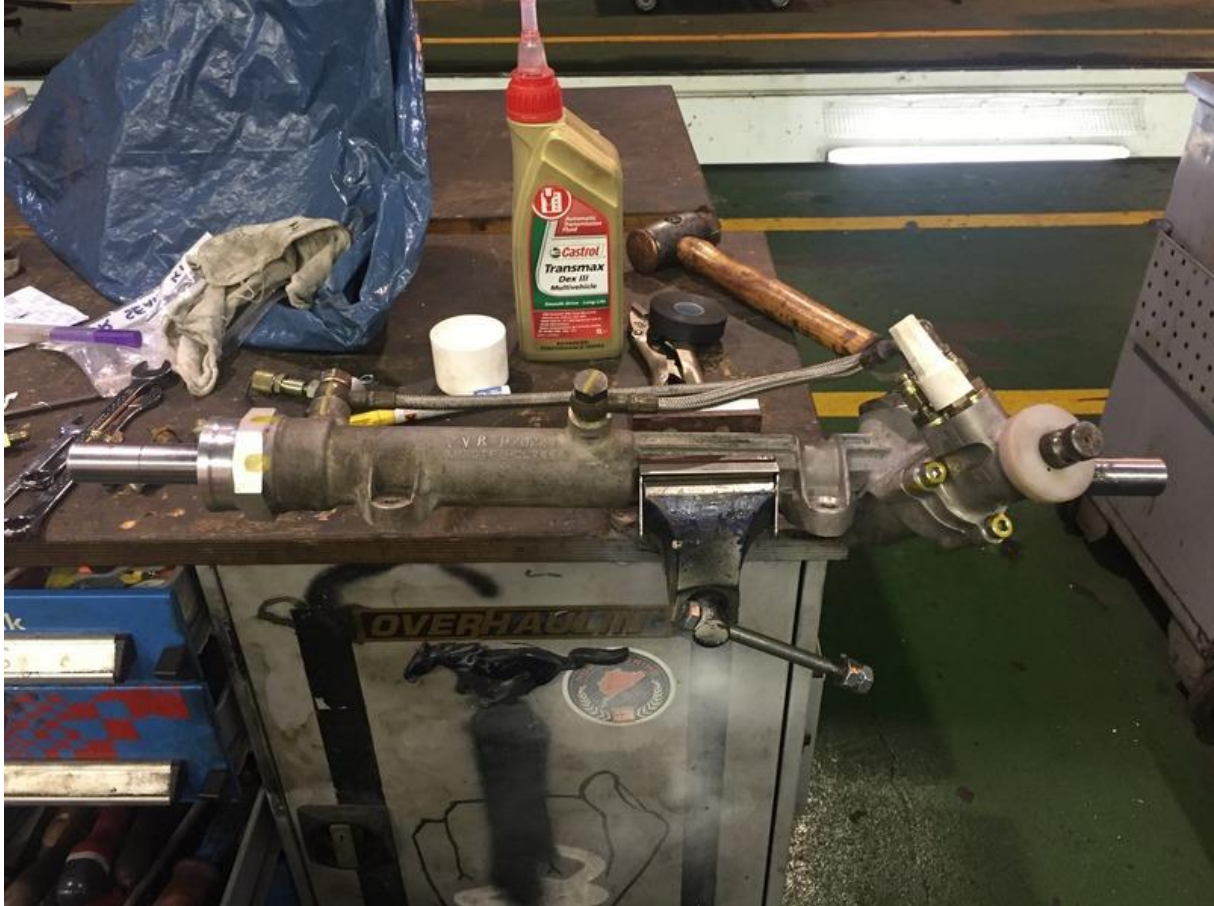
Completed rack, the Loctite lid was just to stop the ATF coming out, which didn't work, so fitted some hydraulic blanks, the fittings are AN6 fittings.

I plan on fitting a filter on the return line when I swap them out, plus new seals in the pump.
